This Service Information bulletin supersedes SI B11 04 04 dated October 2004.

Service Action: E46 M3 S54 Connecting Rod Bearings Replacement

E46 M3 coupe/convertible with S54B32 engine produced from 02/12/2001 up to 05/22/2003

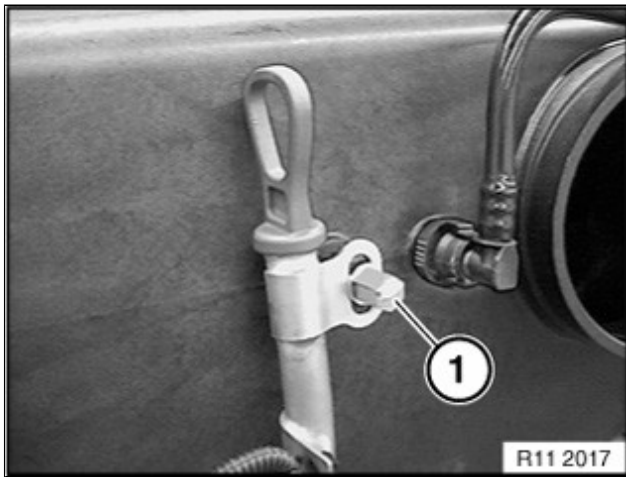
3. Detach guide tube (1) for oil dipstick from the intake manifold.

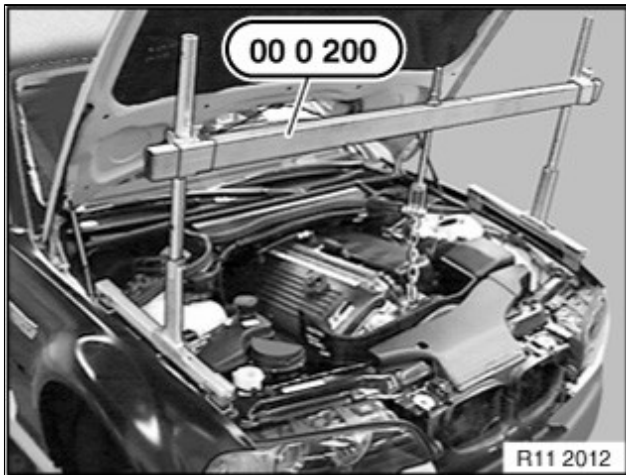
4. Install special tool (p/n 88 88 6 00 0 200 "engine brace") in engine compartment in order to support engine during the repair. For installation instructions refer to RA 11 13 000.

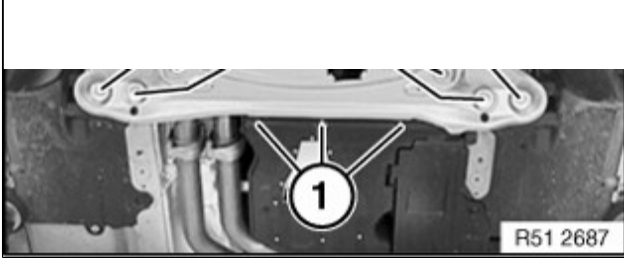
5. Remove engine splashguard. Remove thrust (3) plate on front axle support. For removal instructions refer to RA 51 71 374.

**Important:** When reinstalling thrust plate, use a set of new M10 x 30 x 1.5 screws provided in the parts kit. Then, the

reinforcement plate screws must be tightened in two stages:  
 - first, torque with 59 Nm  
 - then, angle torque to 90°  
 Using Torque Angle Measuring Tool (p/n 90 88 6 009 120 available through the Automatic Tools Shipment Program)

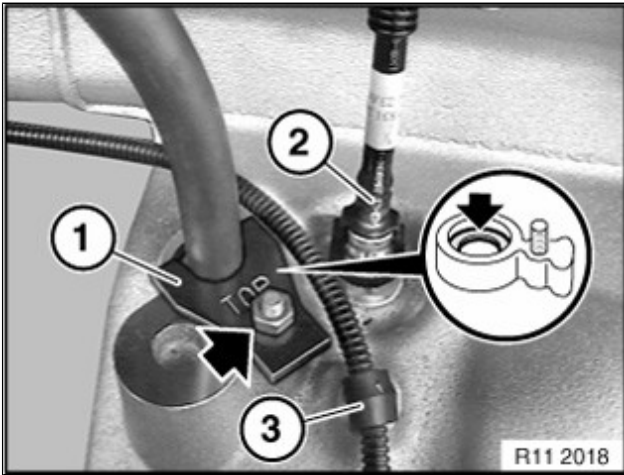
7. Remove dipstick holder (1) from the oil sump, and remove dipstick.

8. Detach oil condensate return hose (2).

**Important:** When reinstalling the oil dipstick, replace the O-ring (as indicated by black arrow) included in the parts kit.

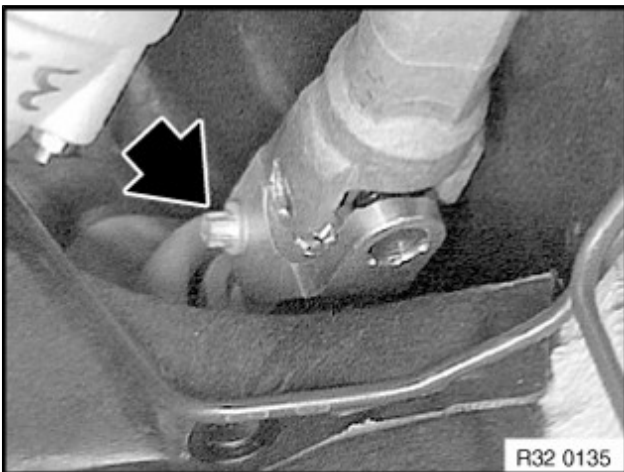
9. Detach steering spindle from the steering rack by removing clamping screw.

**Important:** Use the new clamping screw M8 x 33 (provided in the parts kit) when reinstalling steering spindle. Tightening torque should be 22 Nm.

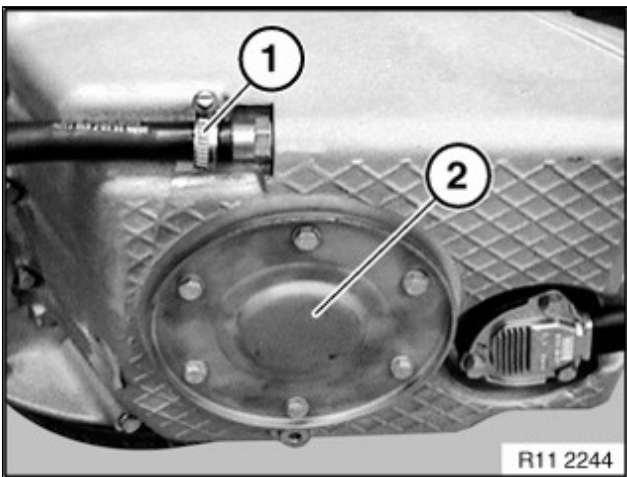
18. Detach return hose (1) from oil sump.

19. Remove cover (2) from oil sump.

20. Disconnect oil level sensor connector.

**Important:** Replace gasket for sump cover (2) when reinstalling oil sump (gasket is provided in the parts kit). For vehicles up to 04/2003 production, Oil Sump Cover Gasket (p/n 11 13 7 832 023) is provided in the parts kit. For vehicles from 04/2003, the new design Oil Sump Cover Gasket (p/n 11 13 7 834 886) has to be ordered separately.

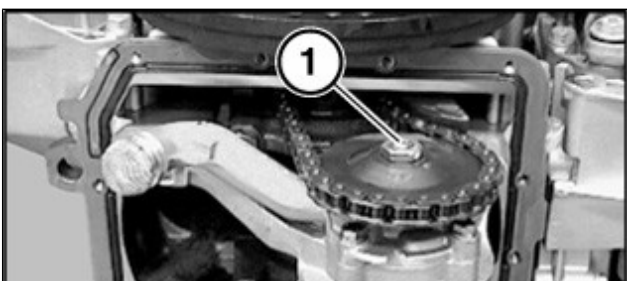
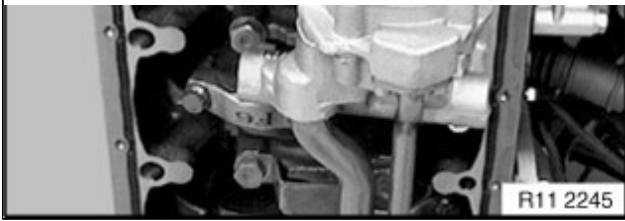
22. Using M17 mm socket remove oil pump sprocket nut (1).

Important: Left-hand threads (turn clockwise to loosen).

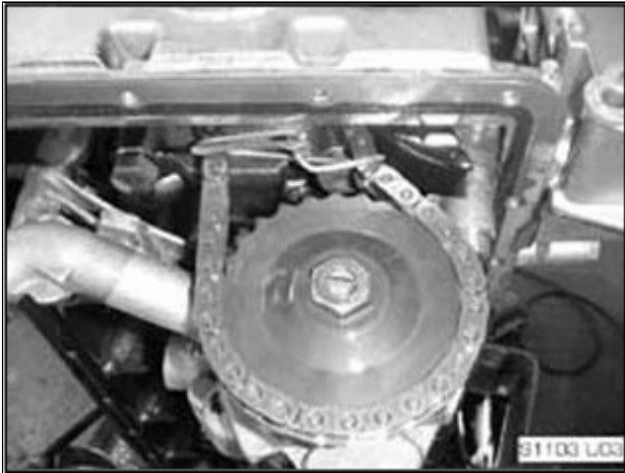
23. **Important:** To reduce tension exerted by the oil pump chain when loosening the sprocket nut, remove all slack existing in the chain. It can be done by tightening chain around the sprocket (as shown on the illustration) with approx. 7" of soft wire (e.g., from a wire hanger). This will protect plastic tensioner from possible damage while loosening the sprocket nut.

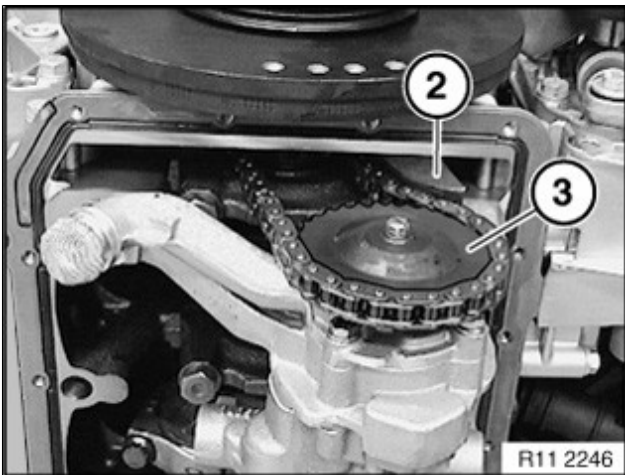
24. Press back the chain tensioner (2). Detach sprocket wheel (3) from oil pump shaft.

**Important:** When reinstalling, align teeth of the sprocket wheel and oil pump shaft. Torque down sprocket nut to 25 Nm.

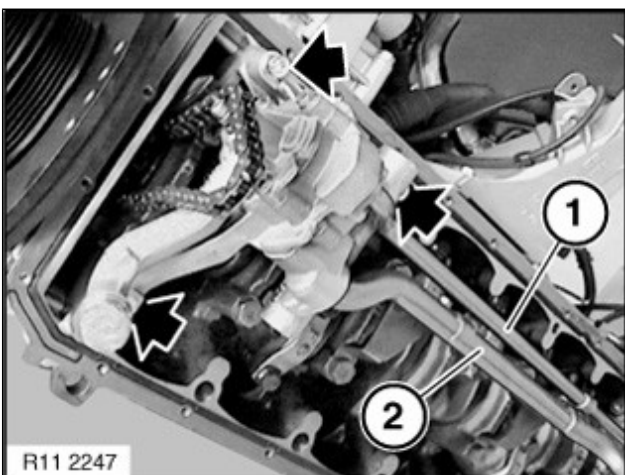
25. Remove oil pump return pipe (1) and suction pipe (2). Remove oil pump.

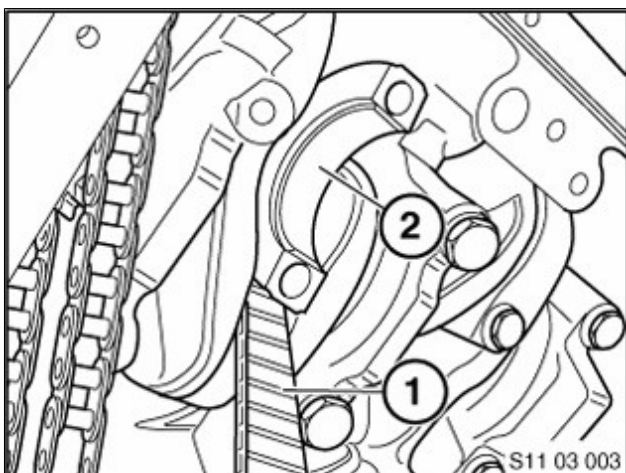
29. Cut off a strip (1) from a clean and fiber-free cardboard with approximate dimensions of 20 mm x 150 mm. Use such a cardboard strip to protect crankshaft bearing surface.

30. After removing connecting rod cap, gently push connecting rod upwards, and then after securing enough clearance from the crankshaft, slowly pull it down in order to remove the upper bearing shell (2).

**Important:** Do not use sharp tools to pry out the bearing shells out of the connecting rod or cap.

**Note:** If the removed connecting rod bearings exhibit signs of excessive wear (e.g.: exposed shiny, copper bedding on the inner surface; missing, sheared-off locking tabs; or deep, shiny grooves on the outer surface indicating "spinning"), then contact the Technical Hotline Drivetrain for further instructions.

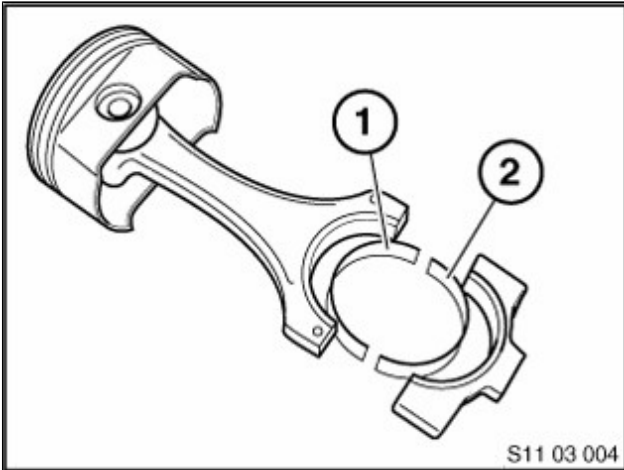
One classification of connecting rod bearings will be used in this Service Action. Connecting rod bearings are color-coded:

- Blue (1) for the connecting rod side
- Red (2) for the cap side.

**Important:** In order to ensure engine reliability, it is essential to install bearing shells in the order specified above.

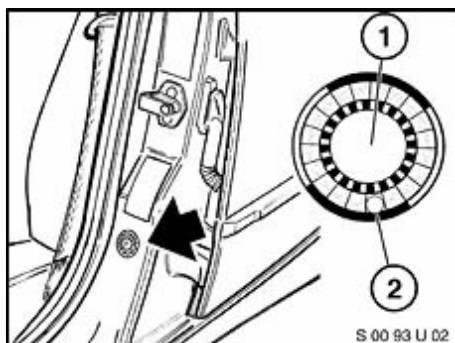
This Service Action has been assigned code number 422 After the vehicle has been checked, and corrected if necessary, obtain a label (SD92-267) and:

- @. emboss your BMW dealer warranty number in the middle of the label (1);
  - a. punch out code number 422(2) printed on the label and,
  - b. affix the label to the B pillar as shown.
