This Service Information bulletin supersedes SI B11 02 08 dated August 2010.

**Power Reduction, FC 2A82 Intake VANOS and/or FC 2A87 Exhaust VANOS Camshaft Faults are Stored in DME**

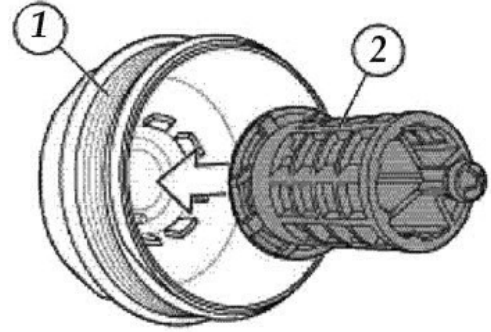
Fig. 1

2. The oil filter cap insert may have been inadvertently removed during the vehicle's last oil service. If this insert is not installed, it will result in non-filtered engine oil being supplied to the engine, thus possibly clogging or damaging the VANOS solenoids.

If the oil filter cap insert is found to be missing, the entire oil filter housing cap must be replaced (refer to the EPC).

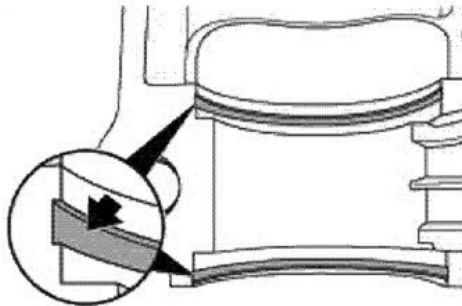
Fig. 3

Note the deep grooves worn into the camshaft bearing ledge by the camshaft hook ring seals in **Fig. 3**. The camshaft bearing ledge is worn.

If excessive wear to the camshaft bearing ledge is found, it is only necessary to replace the camshaft hook ring seals and the affected camshaft bearing ledge. N51, N52 and N52K intake camshaft bearing ledges and hook ring seals cannot be replaced separately. Cylinder head replacement requires a TeileClearing PuMA case.

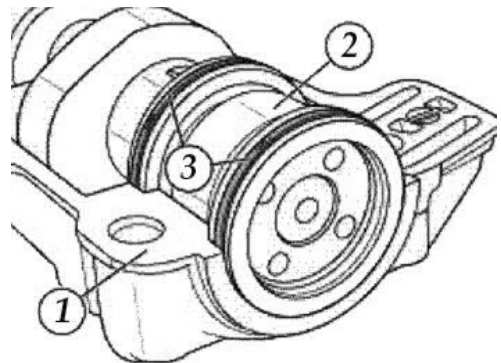
Fig. 2

**Figs. 2, 3 and 4** are illustrations of worn camshaft bearing ledges and the acceptable wear of the camshaft bearing ledge.

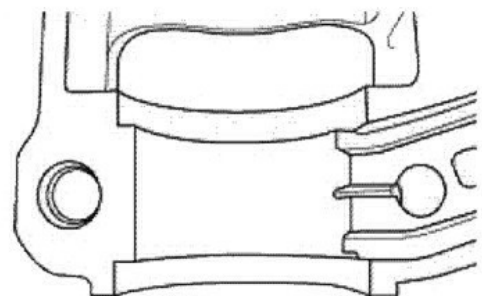
Fig. 4

**Fig. 4** shows acceptable camshaft bearing ledge — minor gray wear marks from the rotation of the camshaft are normal. If deep grooves are not apparent, the camshaft bearing ledge is acceptable and should not be replaced.
