NUMBER: 09-010-06

GROUP: Engine

Multiple Cylinder Misfire Or Rough Idle

2004 - 2006	(CS)	Pacifica
2005 - 2006	(LX)	Chrysler 300/Magnum/Charger

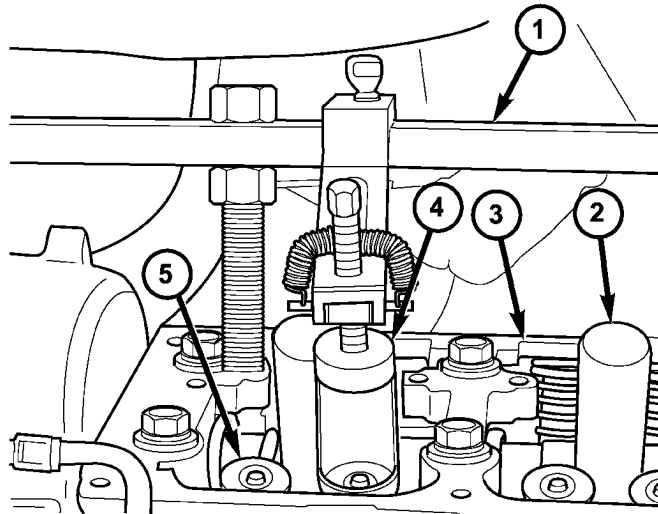
Fig. 1 VALVE SPRING COMPRESSION

The misfire condition may be caused by one or more engine exhaust valves that are slow to close due to a build up of carbon on the valve stem.

9. Using Tool MD 998772A (1) with adapter 6527 (4) or equivalent, **slightly compress** the exhaust valve spring to release tension against the valve and valve spring retainer (Fig. 1).

11. Using **needle nose pliers** grab the tip of the valve stem and rotate the exhaust valve 90° (move the mark to the 3 O'clock position).
12. Install two new valve spring retainer locks, p/n 53022277AA.

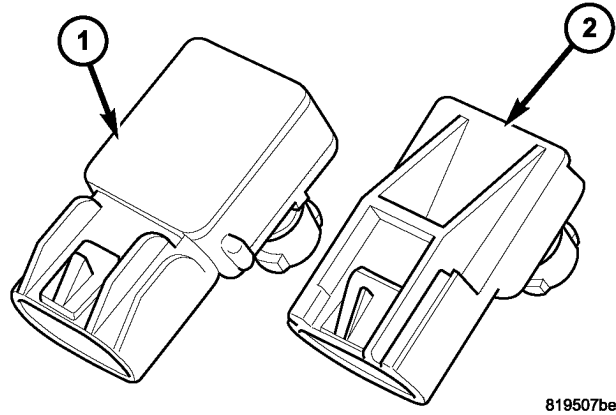
Fig. 2 LX MODELS - MAP SENSOR

- 1 - NEW STYLE SENSOR (p/n 05033310AC)
 - 2 - OLD STYLE SENSOR
-

2. Replace the MAP sensor with p/n 05033310AC for LX models or p/n 04896003AB for CS models. If the vehicle is a CS model, be sure the new sensor opening is facing a downward direction when installed and only use one fastener. Refer to the detailed service information available in TechCONNECT, under: Service Info > 14-Fuel System > Fuel Injection > MAP Sensor > Removal and Installation. When complete, proceed to Decarboning Combustion Chamber and Valves.

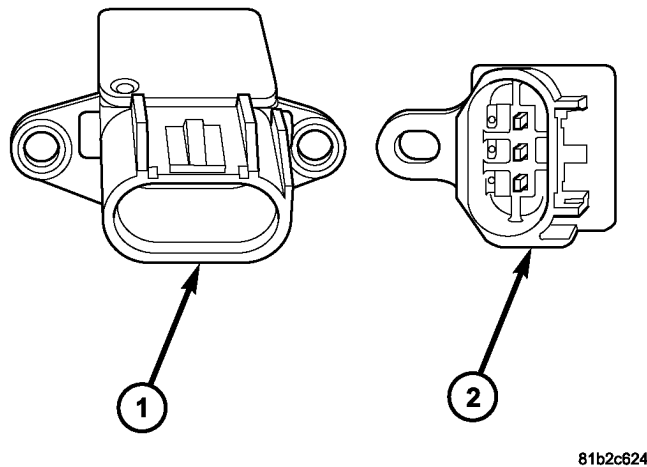
Fig. 3 CS MODELS - MAP SENSOR

- 1 - NEW STYLE SENSOR (p/n 04896003AB)
 - 2 - OLD STYLE SENSOR
-
