Noise During Start Up – Install Revised Timing Chain Tensioners

MODEL1997-99 MY XK8 Range
1998-99 MY V8 XJ Series**VIN**Refer to engine
no. in text**Issue:**

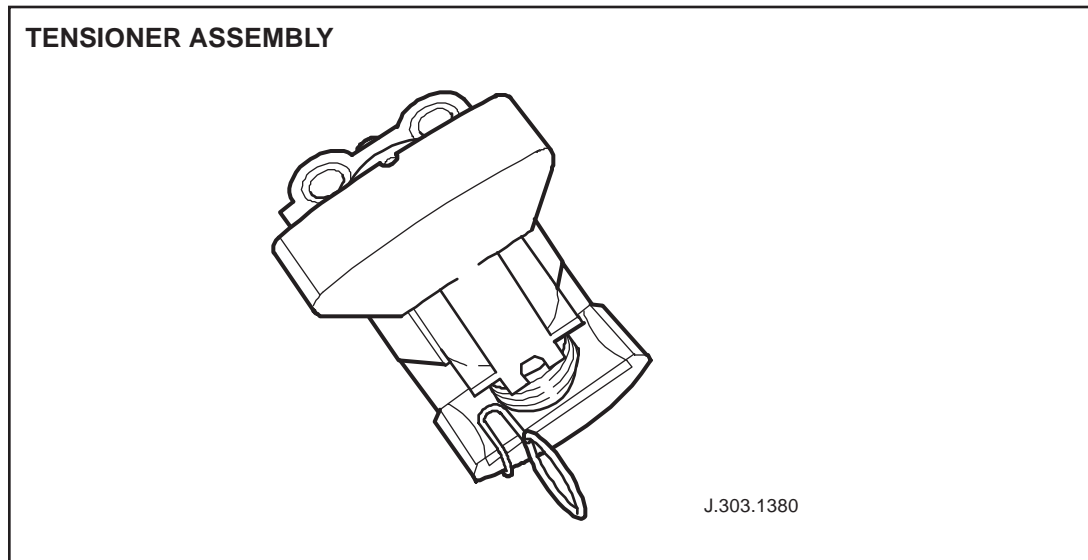
ILLUSTRATION 1

- The revised tensioner has a coil spring that presses on the piston head to provide a damping effect.
- To simplify the installation of the tensioner on the engine, a clip (shown in Illustration 2) is provided to hold the piston in a partly compressed position during assembly.

In case of a customer complaint of start up noise, determine if the noise is caused by the secondary timing chain tensioners. If the secondary timing chain tensioners are the cause of the noise, they should be replaced by the revised tensioners (Illustration 1).

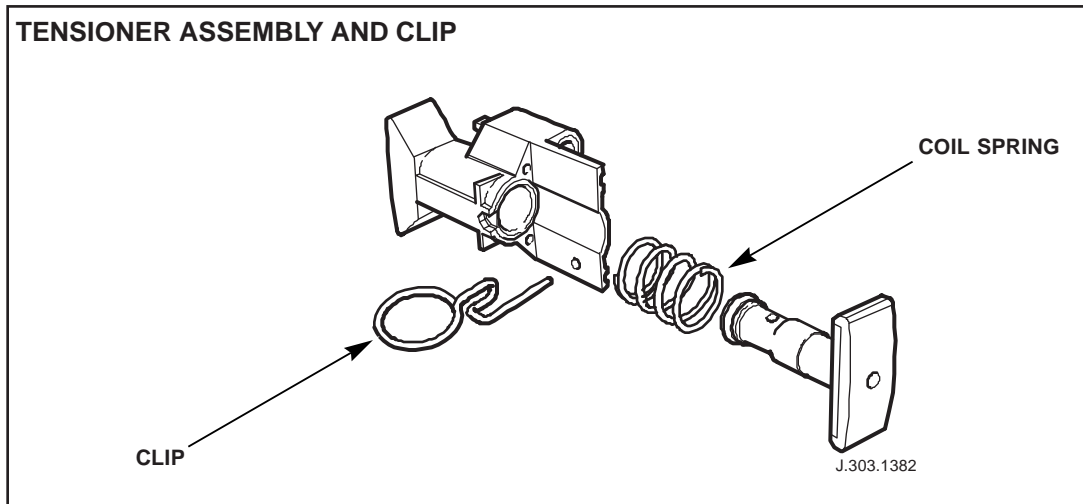
ILLUSTRATION 2

- When the piston and spring assembly is compressed to approximately half of its travel, the pin end of the clip is inserted into the hole in the tensioner body, in front of the piston head/slipper, with the finger ring of the clip positioned at the rear of the head, (as shown in Illustration 1).
- Installation of the tensioners is covered in JTIS 5, section 303-01, Basic Engine, Removal and Installation, Timing Chain Tensioner (Secondary) - A-Bank (12.65.63) or Timing Chain Tensioner (Secondary) - B-Bank (12.65.64).
- The method of removing and reinstalling the secondary timing chain tensioners has been simplified by the use of a ball-end drive bit as described in Technical Bulletin 303-28, dated 8/98.
