V8 XJ Series/XK

303-S514

# TECHNICAL BULLETIN

## Operation Of Throttle While In Closed Position – Service Action S514

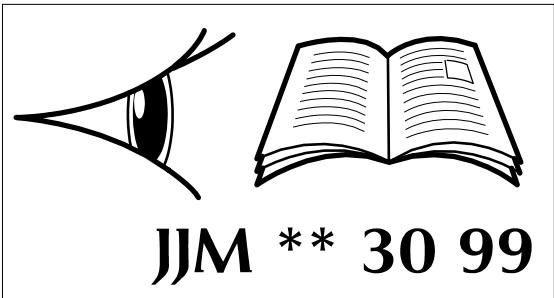
ILLUSTRATION 11

**Note:** The new throttle body has a Molykote coating and cannot be cleaned. The new throttle bodies can be identified by a sticker (Illustration 11).
