V8 XJ Series/XK

413-S484

TECHNICAL BULLETIN

Instrument Pack Assembly – CAN Failure – Service Action S484

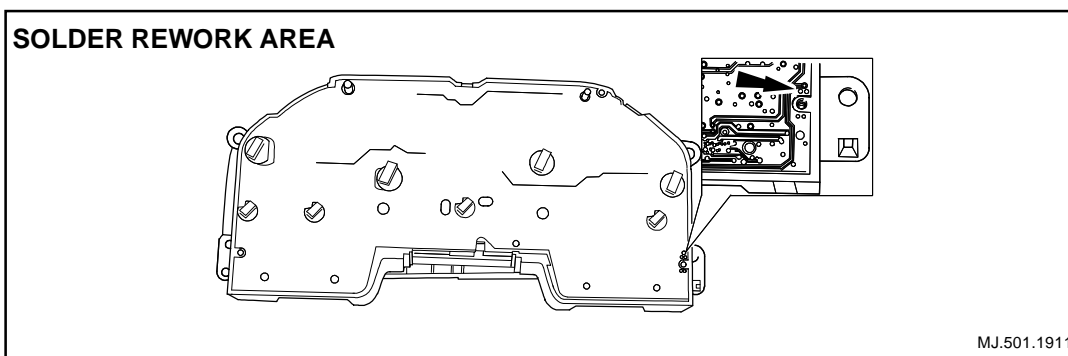
ILLUSTRATION 1

6. Place instrument pack on mat face down - use care not to damage the lens.
7. Undo and remove module back plate securing screws. (Torx T20)
8. Displace back plate using hinge action on paper adhesive label and place aside - careful not to rip the label.
9. Carefully remove back plate from the paper adhesive label and place aside - do not rip the label.
10. Examine circuit board to determine if rework to solder area is required. (Refer to Illustrations 1 - 4).
