**Steering Rack – Leak at Transfer Pipe
Union Nut – Replace O-rings**MODEL 1997 MY-ON
XK8 Range
VIN
001001-ON**Issue:**

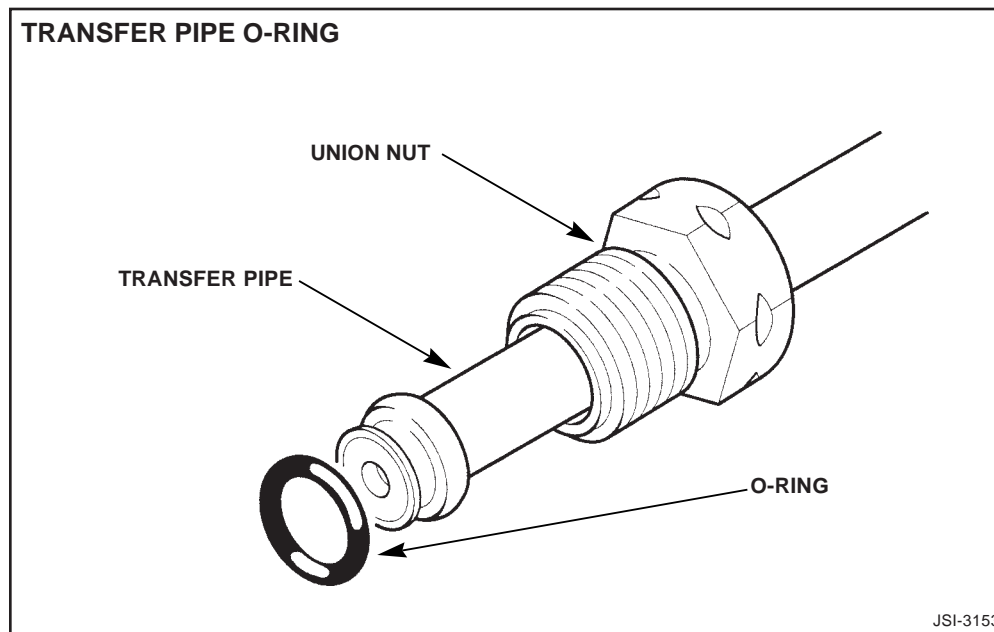
ILLUSTRATION 1

The steering rack of some 1997 MY-ON XK8 vehicles may leak at one of the transfer pipe union nuts. The cause of the leak is damage to the O-ring seal beneath the union nut caused during installation. Before replacing the entire steering rack, the O-ring (Illustration 1) should be replaced and the system tested.

18. Discard the O-rings that were removed.
19. Thoroughly clean the areas around the threaded ports, lubricate the replacement O-rings and then install them to the transfer pipes.

20. Install the transfer pipes on the rack assembly, using care not to damage the O-rings against the thread in the port.

21. Thread the union nuts and lightly tighten them while checking that the pipes and the O-rings are properly seated in the bores.
22. Using a crowfoot wrench on a torque wrench, tighten the union nuts to 7 - 8 Nm (5.2 - 5.9 lb ft or 62 - 70.8 lb in).
23. Raise the rack into position on the crossmember, place the return hose behind the pipes and then install the retaining bolts.
24. Tighten the retaining bolts to 30 - 40 Nm (22.1 - 29.5 lb ft).
25. Thoroughly clean the areas around the threaded bores of the feed and return ports, lubricate the replacement O-rings and then install them to the feed and return pipes.
26. Install the feed and return pipes into the pinion housing, align the retaining bracket and then install and tighten the retaining bolt.
27. Clean the rack assembly of any spilled fluid.
28. Install the feed pipe insulation sleeves.

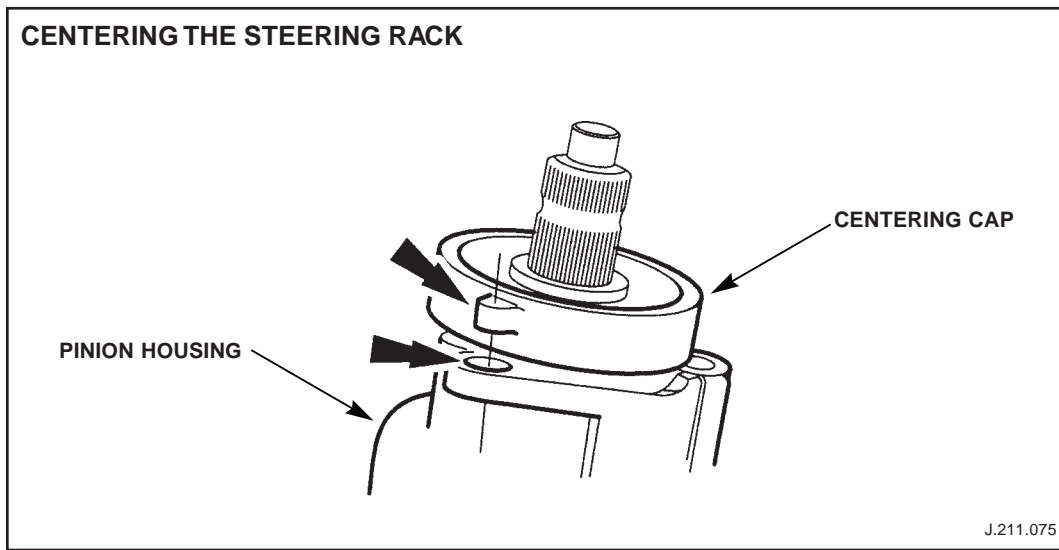
ILLUSTRATION 2

4. Align the pinion centering cap with the lug on the pinion housing (Illustration 2) to precisely center the rack.
