DTC P1396 (VVT Solenoid
Malfunction - B bank) –
Diagnosis and Repair

MODEL 1997 MY-ON
XK8 Range
VIN
001001-011682

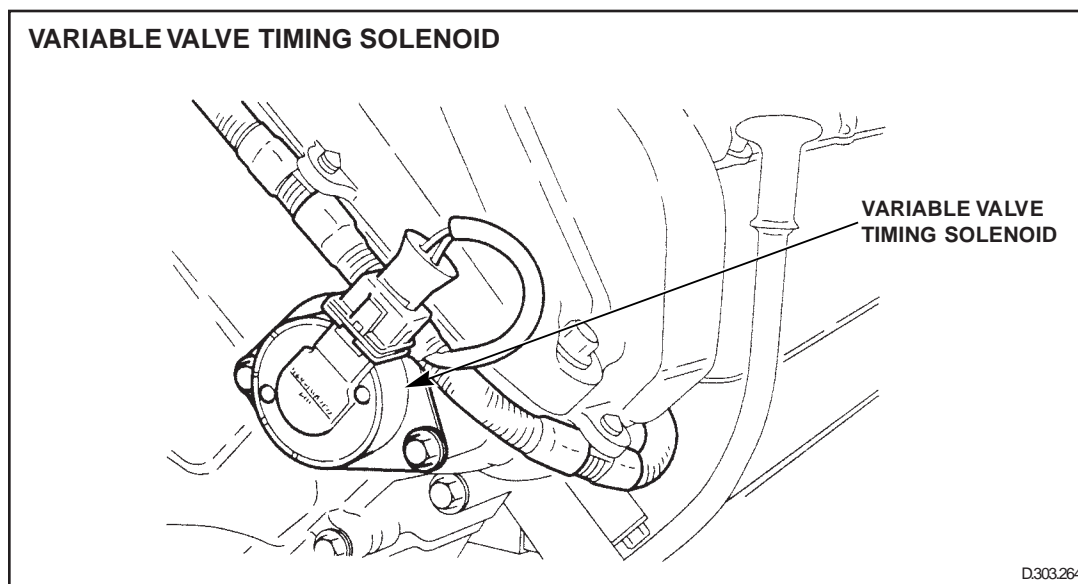
ILLUSTRATION 1

1. Load the PDU at the base station and connect the PDU to the data link connector.
2. Use the PDU to display the recorded DTC(s). If DTC P1396 is recognized as the system fault, proceed to step 3.
3. Disconnect the B bank VVT solenoid connector (Illustration 1.)

4. After removing the securing screws, remove the VVT solenoid from the timing cover.
5. Remove and discard the O-ring seal from the solenoid.
6. Apply battery voltage to the solenoid connector pins to verify that the solenoid plunger operates correctly.

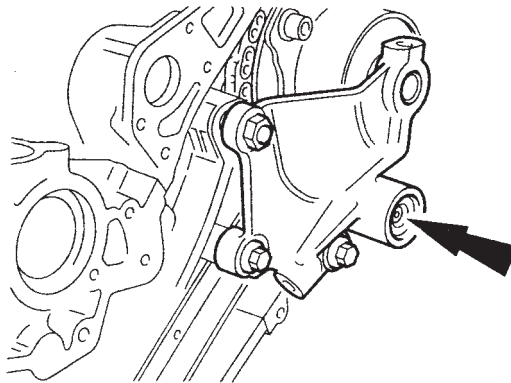
ILLUSTRATION 2

VVT ACTUATING VALVE (SHOWN WITH TIMING COVER REMOVED)

7. Insert a suitable rod through the VVT solenoid mounting opening in the timing cover, into the actuating valve (Illustration 2.)
8. Cover the area surrounding the rod and the timing cover opening with absorbent material to absorb any oil spilled when the engine is run.

9. Start the engine.
10. With the engine at ambient temperature and running at idle, press on the rod to operate the actuating valve, which will in turn operate the VVT actuator. When the engine is cold, the idle speed will become uneven when the VVT operates. This verifies that the VVT actuator operates correctly.

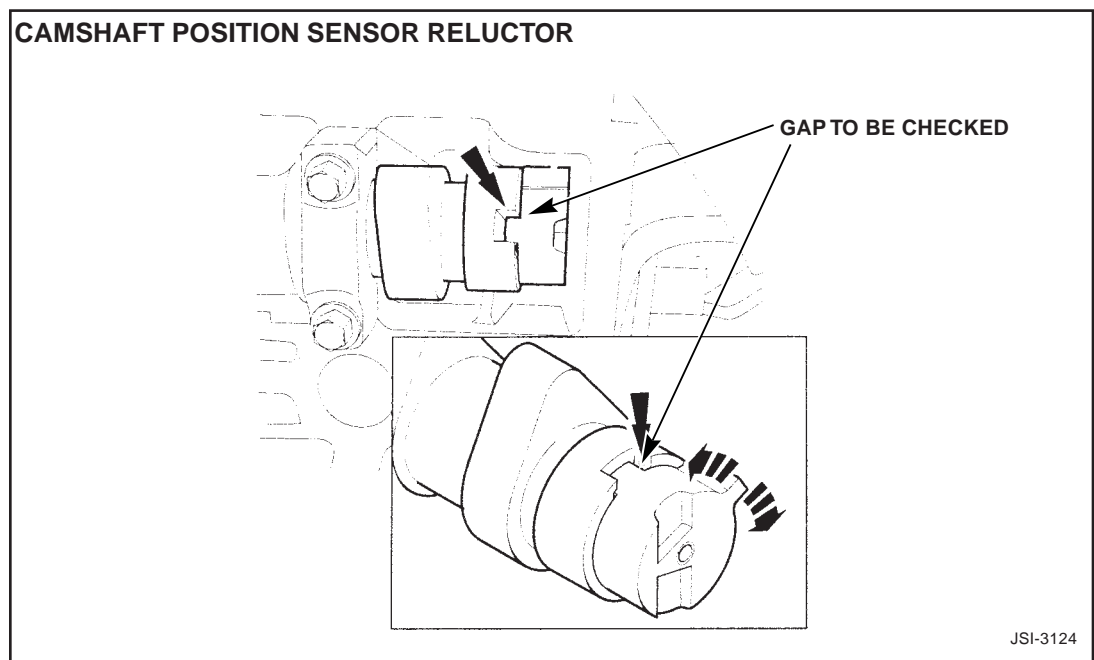
ILLUSTRATION 3

A limited number of engines, in vehicles within the above VIN range, may have a reductor misalignment which would result in DTC P1396 being stored.

7. Remove and discard the outer and inner gaskets from the camshaft cover.
8. Rotate the crankshaft until you can observe the position of the camshaft position sensor reluctor. The reluctor (Illustration 3) should be centered in the drive slot without a noticeable gap at either side. Illustration 3, for example, shows a gap at the arrow meaning that the reluctor is advanced. If the gap were at the other side, the reluctor would be retarded. If the reluctor is not positioned properly, proceed to step 9, otherwise proceed to step 12, then refer to DTC summaries manual for other possible causes for DTC P1396.

9. Use suitable locking pliers to hold the camshaft on the unfinished area between cylinders 3 and 4, at the cast-in flat projection.
10. Lightly strike the reluctor lobe, while tensioning the camshaft in the opposite direction, to re-position the rotor against the opposite face of the slot.
11. Remove the locking pliers from the camshaft.
