NUMBER  
015 (Revised)

MODEL  
Amanti, Sorento,  
Sedona

DATE  
January 2004

### 3.5L Sigma Engine Cylinder Block Damage

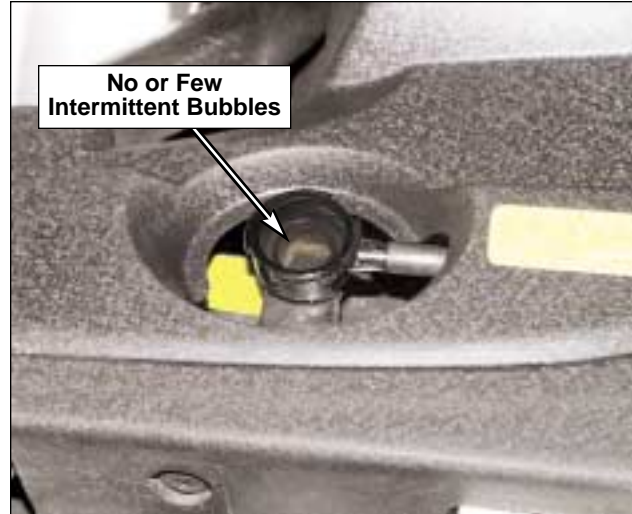
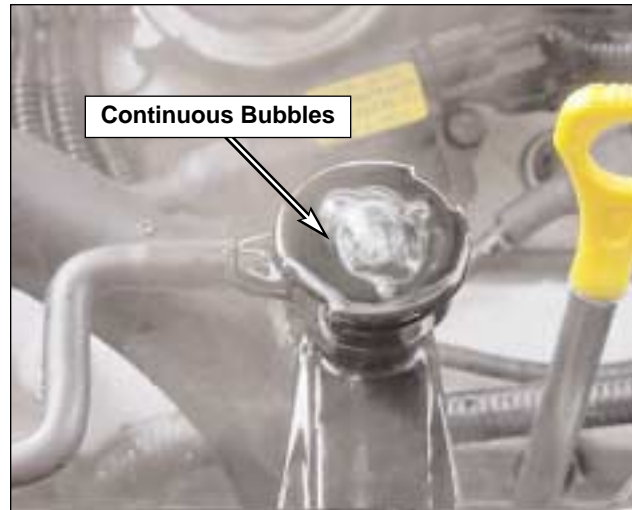
2. Open hood of vehicle and remove radiator cap.
3. Add coolant, if necessary to bring level to bottom of filler neck.
4. Start engine and allow to idle until coolant circulates and radiator fan cycles on, while watching for bubbles at filler neck.

5. If no bubbles or a few intermittent bubbles are noted after the radiator fan cycles 2 times, NO FURTHER ACTION IS REQUIRED. If vigorous, continuous bubbles are noted, proceed to REPAIR PROCEDURE.

1. **Contact your District Parts and Service Manager for a new engine sub-assembly, and install according to instructions in the Service Manual.**

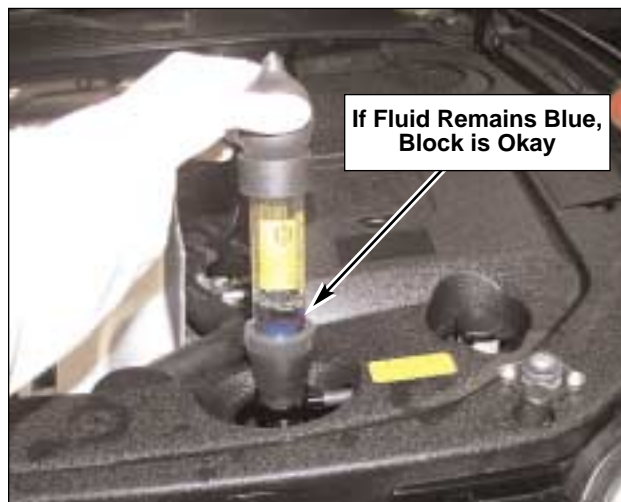
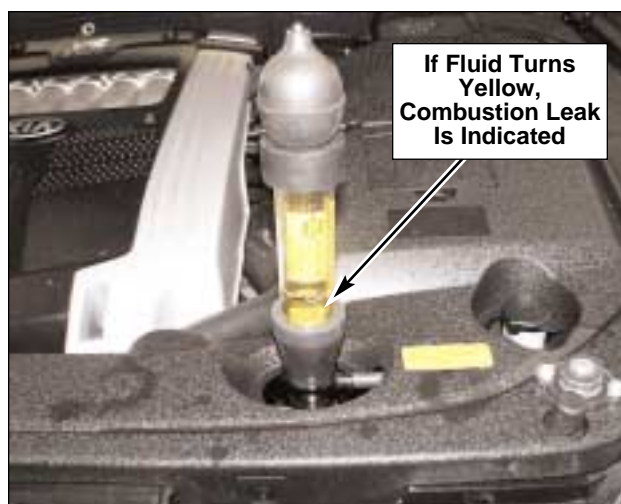
6. With radiator cap still off, drain or siphon fluid down to the bottom of filler neck.
7. Add test fluid to tester and perform test according to instructions for your equipment.
8. If fluid turns yellow, go to REPAIR PROCEDURE.  
If fluid stays blue, NO FURTHER ACTION IS REQUIRED.
