# TECHNICAL BULLETIN

No: LTB00041  
Issue: 2  
Date: 24 May 2007

## Reduced Power Under Load Possible DTC P0096 and/or P2601 Stored

Range Rover (LM) Supercharged	6A198058 to 7A261419
Range Rover Sport (LS) Supercharged	6A901924 to 7A109767

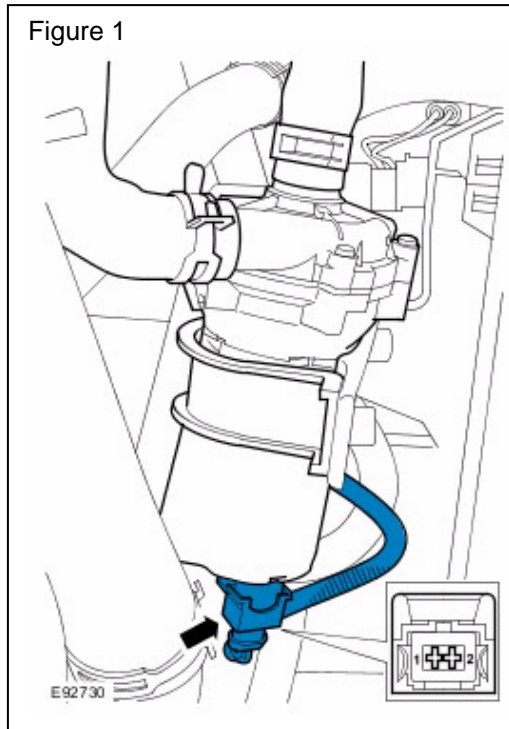
Figure 1

**Situation:** The customer may complain of reduced power and or a misfire at high engine loads and road speeds, with the possibility of Diagnostic Trouble Codes (DTC) P0096 and/or P2601 stored. The electrical harness power supply and ground for the auxiliary coolant pump may be cross connected in connector C3006. The pump will run backwards causing the Engine Control Module (ECM) to reduce power to prevent damage because the pump flow is low. The auxiliary coolant pump will be degraded under these conditions.

1. Release the connector locking tab and disconnect connector C3006 from the coolant pump (Figure 1)

2. Inspect the wires to determine if they are crossed.

- Black (B) wire in Cavity 1 connected to "-" pump connection
- Brown and Purple (NP) wire in Cavity 2 connected to "+" pump connection

- Brown (N) wire in Cavity 1 connected to "-" pump connection
- Red and White (RW) wire in Cavity 2 connected to "+" pump connection

3. If the wires are crossed, use terminal extractor tool YRW9000010 from the Harness Repair Kit and swap cavity 1 and cavity 2 wires to the positions indicated above.

6. If the wires were crossed in connector C3006 or the fault codes P0096 or P2601 are stored, refer to GTR section: 303-03D (26.50.26) and install a new supercharger coolant pump.
7. If the coolant pump is replaced, perform a final IDS check as follows:
  - Connect the battery charger and re-connect the VCM to continue the session.
  - Use IDS, following the on-screen instructions, to clear DTCs.
  - When the task is completed, exit the current session.
8. Disconnect IDS and the battery charger/power supply.
