**Technical Service  
Information Bulletin**

Title: **REAR COIL SPRING CLICKING NOISE**

Models:  
**'01 –'02 GS 430/300**

**SUSPENSION  
SU005-02**

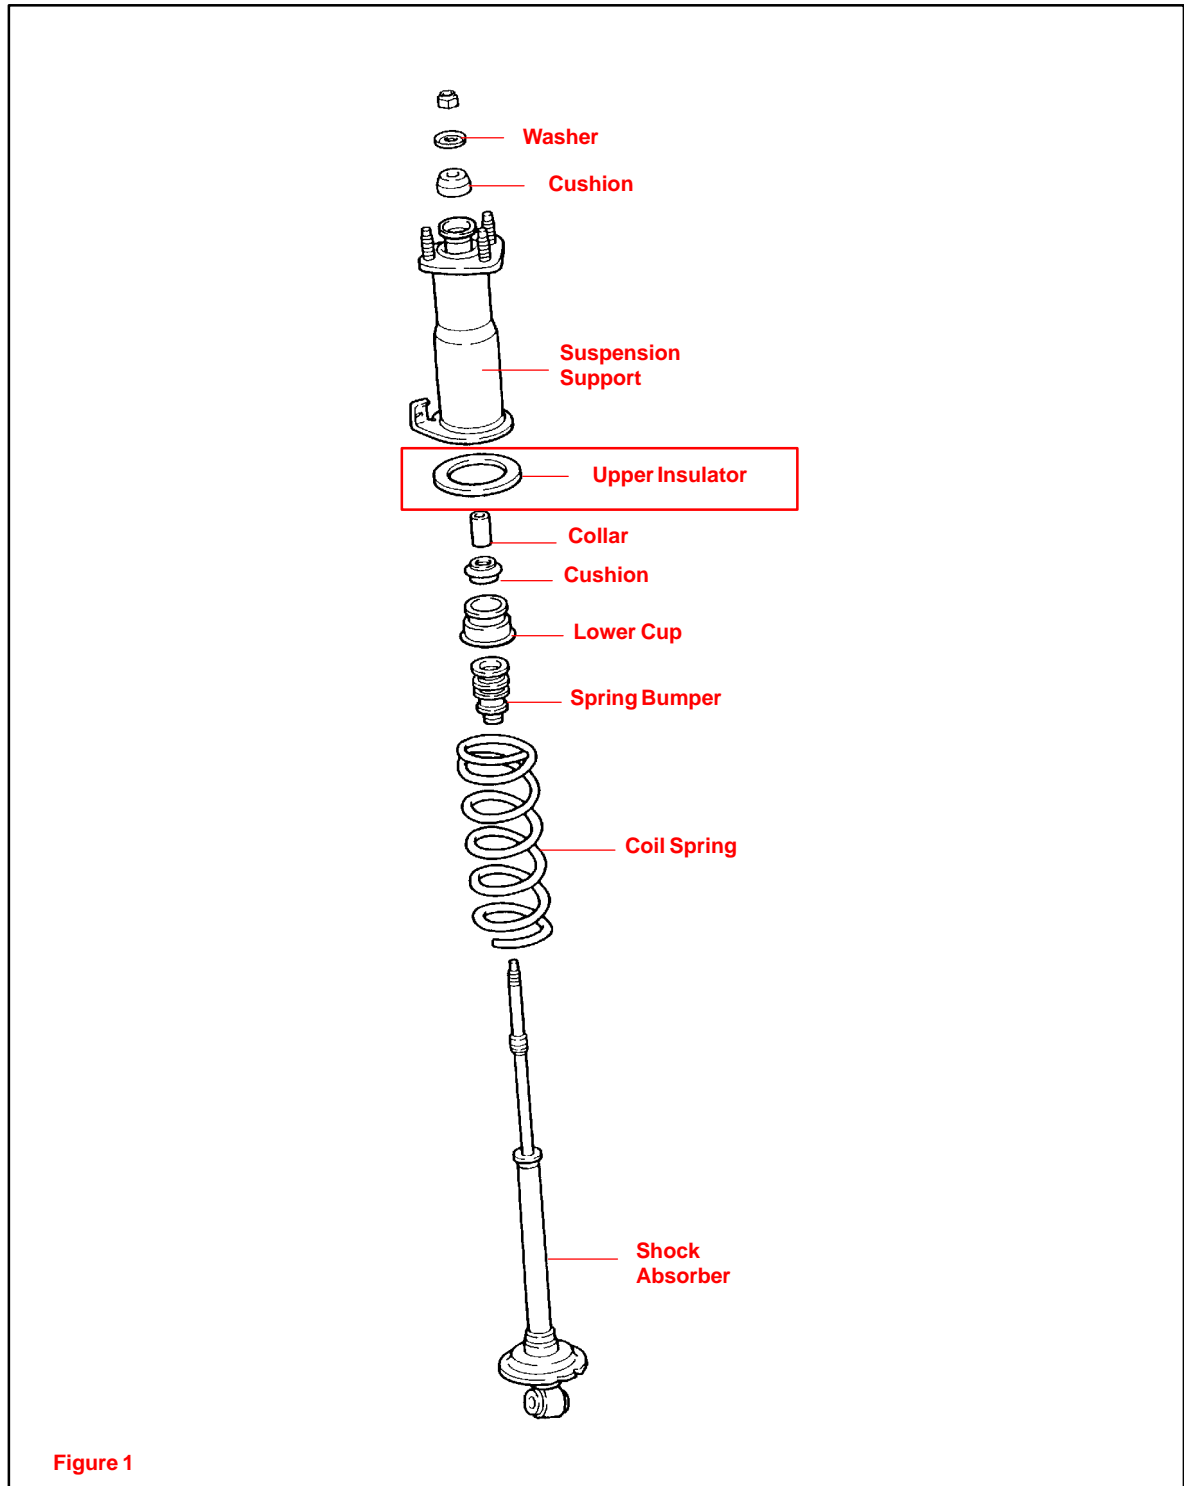
**Introduction** During the rear strut assembly process, the coil spring upper insulator may have become deformed or unseated causing a metal to metal interference between the upper end of the coil spring and the spring upper support (suspension support). This interference may result in a clicking noise from the rear suspension when driving over bumps.

1. Remove the rear strut assembly and separate the rear coil spring(s) from the strut assembly following the Repair Manual procedures.
2. Visually check the coil spring upper insulator (location shown in Figure 1).
3. If the upper insulator shows signs of damage, it should be replaced.
4. Reassemble the strut assembly. Verify the spring is properly seated and the insulator is not damaged prior to installing the strut assembly in the vehicle.
5. Reinstall the rear strut assembly and verify rear suspension alignment.
