<b>Subject:</b> <b>WHITE OR BLUE SMOKE FROM TAIL PIPE AFTER LONG IDLE PERIOD</b>	<b>Bulletin No:</b> 01-002/11
	<b>Last Issued:</b> 04/21/2011

2007-2009 CX-7 vehicles with VINs lower than JM3ER\*\*\*\*9\*224013 (produced before July 1, 2008)

2007-2009 Mazdaspeed3 vehicles with VINs lower than JM1BK\*\*\*\*9\*187397 (produced before July 1, 2008)

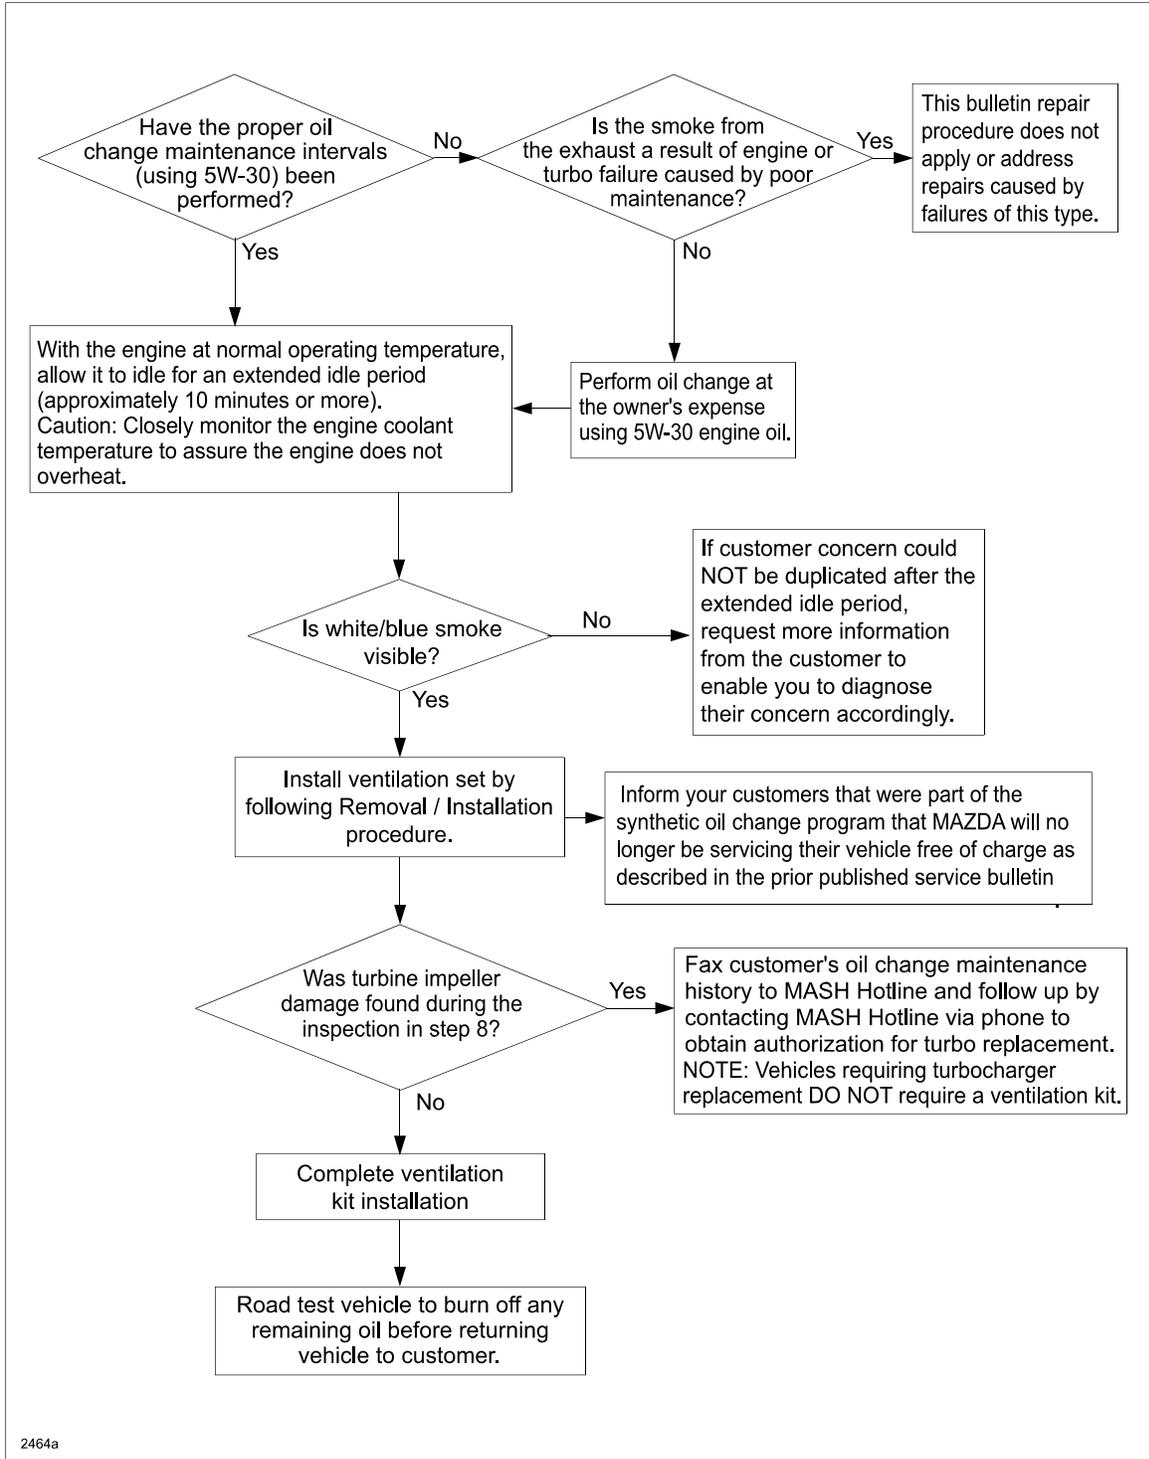
If the proper oil change intervals using 5W-30 have been performed, repair the vehicle using the following repair procedure.

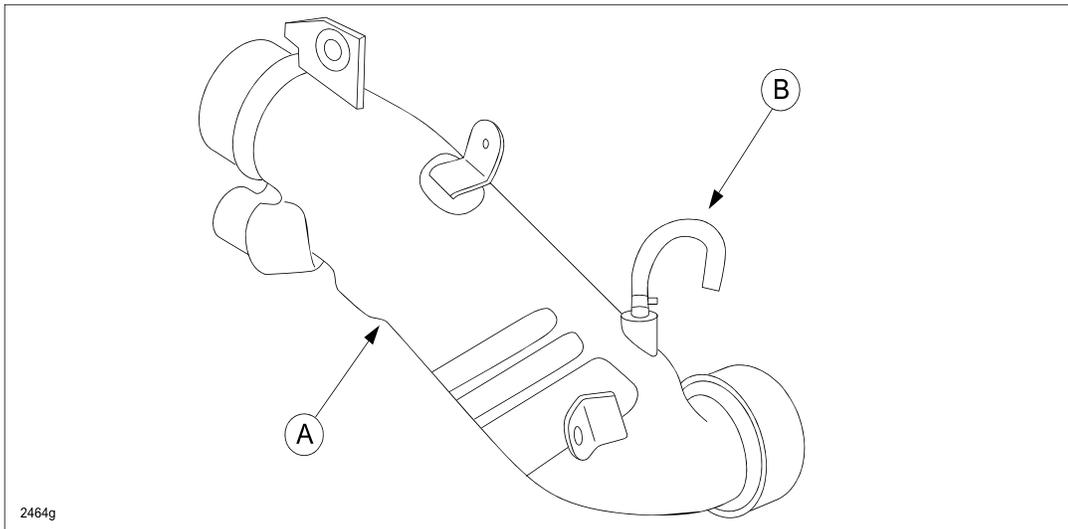
8. Inspect turbocharger for impeller contact damage due to bearing failure.

7. Remove the air pipe (A) with vacuum hose (B).

- If impeller damage is found, discontinue the ventilation kit installation procedure. Contact the Technical Assistance Hotline for turbocharger replacement authorization.
- If impeller damage is not found, proceed to next step.
