## SERVICE BULLETIN

**APPLICABILITY:** 2013-2014MY BRZ

**NUMBER:** 07-120-17R

**SUBJECT:** Ignition Coils and Engine Harness- Design Changes to Address DTCs P0351, P0352, P0353 and / or P0354

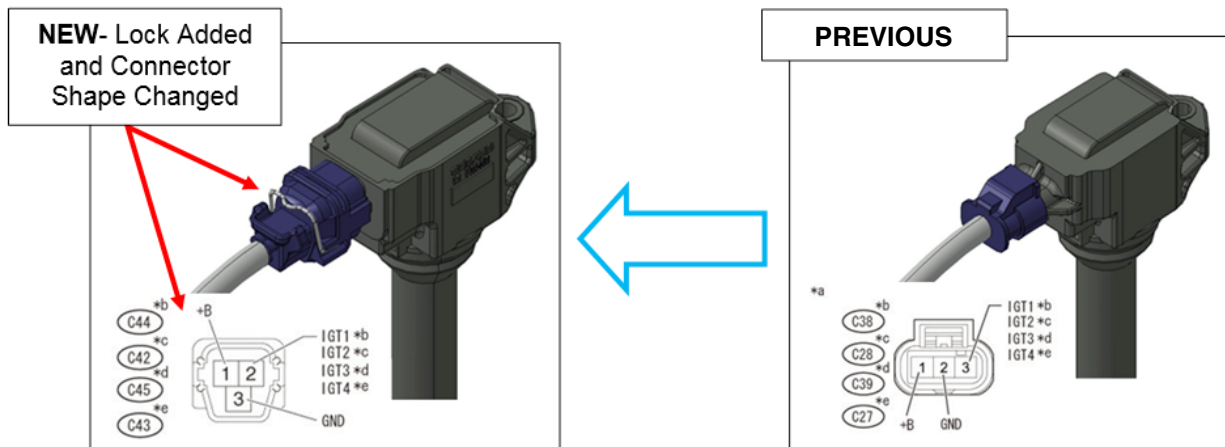
### PART INFORMATION:

This Service Information Bulletin announces design changes made to the ignition coil and engine wiring harness in response to a limited number of cases related to the ignition coil primary / secondary DTCs listed above. The changes involve a shape change to the harness connector on the coil and to the corresponding engine harness connector. A positive lock mechanism has also been added to the engine harness ignition coil connectors to reduce the chances of becoming disconnected and causing a driveability concern and / or DTC(s).
