EG-0008T-01 12

# Technical Service Bulletin

Subject: 1KD-FTV engine: piston crack	Engine
Models: HILUX; LAND CRUISER	
Model codes: KUN26; KDJ120; KDJ125; KDJ150; KDJ155

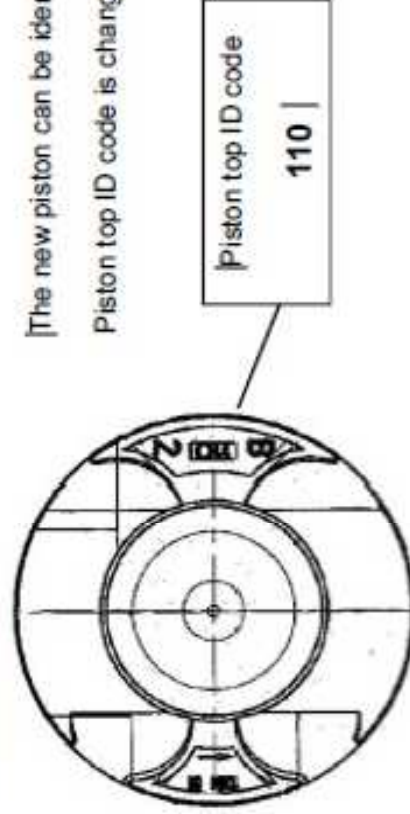
[The new piston can be identified by the piston top ID code.

Piston top ID code is changed from 080 to 110 |

It is advised to confirm the piston top ID code upon arrival of the new parts. If an older version of pistons is installed, replace them by new ones.
