# Technical Bulletin

Model(s)	Year	Eng. Code	Trans. Code	VIN Range From	VIN Range To
All	2008-2010	2.0L (CBFA, CCTA)	All	All	All

21 10 01 August 25, 2010 2024061

### Rattling Noises from Engine Compartment Area or Exhaust System

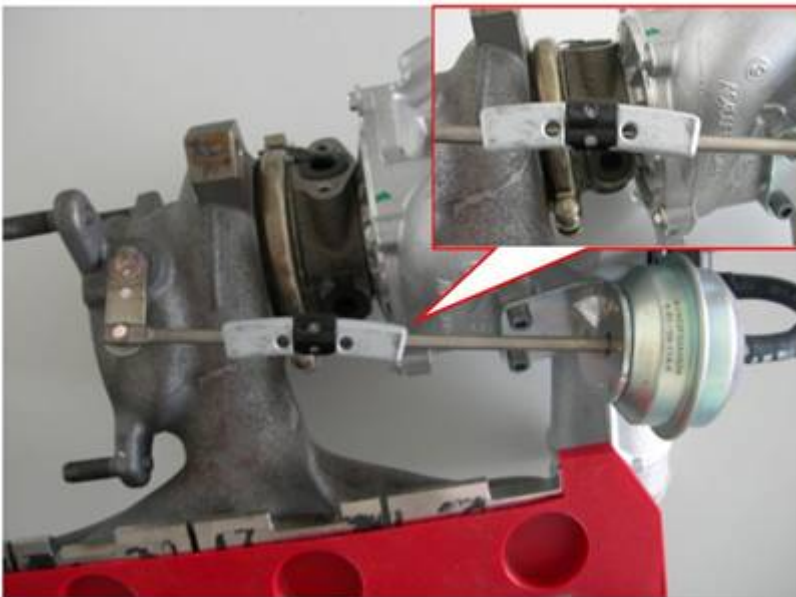
Figure 1

1. Ensure that there is no physical internal or external damage to the turbocharger. If damage is observed, continue diagnosis and repair as necessary. If no damage is observed, proceed to step 2.
2. Test drive the vehicle to duplicate and familiarize yourself with the noise. Noise can typically be duplicated by driving up a moderate incline, beginning at 35 mph in 4<sup>th</sup> gear (manual or automatic transmission) and accelerating through the RPM range of 1800-3000 RPM under moderate to heavy throttle. Obey all local traffic laws.
3. Once you have confirmed and familiarized yourself with the noise, attach a 2 ounce wheel weight to the wastegate actuator rod (figure 1) and take the vehicle for another test drive.

Because of exhaust gas pulsations the wastegate flap and actuator rod vibrate at the introduction of boost pressure.

If after attaching the weight to the actuator rod the noise is quieter or has changed in pitch, **DO NOT** replace the turbocharger. Remove the weight, create a VTA ticket in ElsaWeb and contact the Volkswagen Technical Helpline at 800-678-2389.

If after attaching the weight to the actuator rod the noise has not changed, remove the weight and continue diagnosis and repair as necessary.
