<b>Subject:</b> <b>KNOCKING / SQUEAKING NOISE FROM FRONT SHOCK ABSORBER, CREAKING NOISE FROM FRONT LOWER ARM BUSHING</b>	<b>Bulletin No:</b> 02-010/16
	<b>Last Issued:</b> 10/10/2016

2016 CX-3 vehicles with VINs lower than JM1 DK \*\*\*\*\* 136727 (produced before March 07, 2016)

2013-2016 CX-5 vehicles with VINs lower than JM3 KE \*\*\*\*\* 742261 (produced before November 16, 2015)

2014-2016 Mazda6 vehicles with VINs lower than JM1 GJ \*\*\*\*\* 459655 (produced before November 16, 2015)

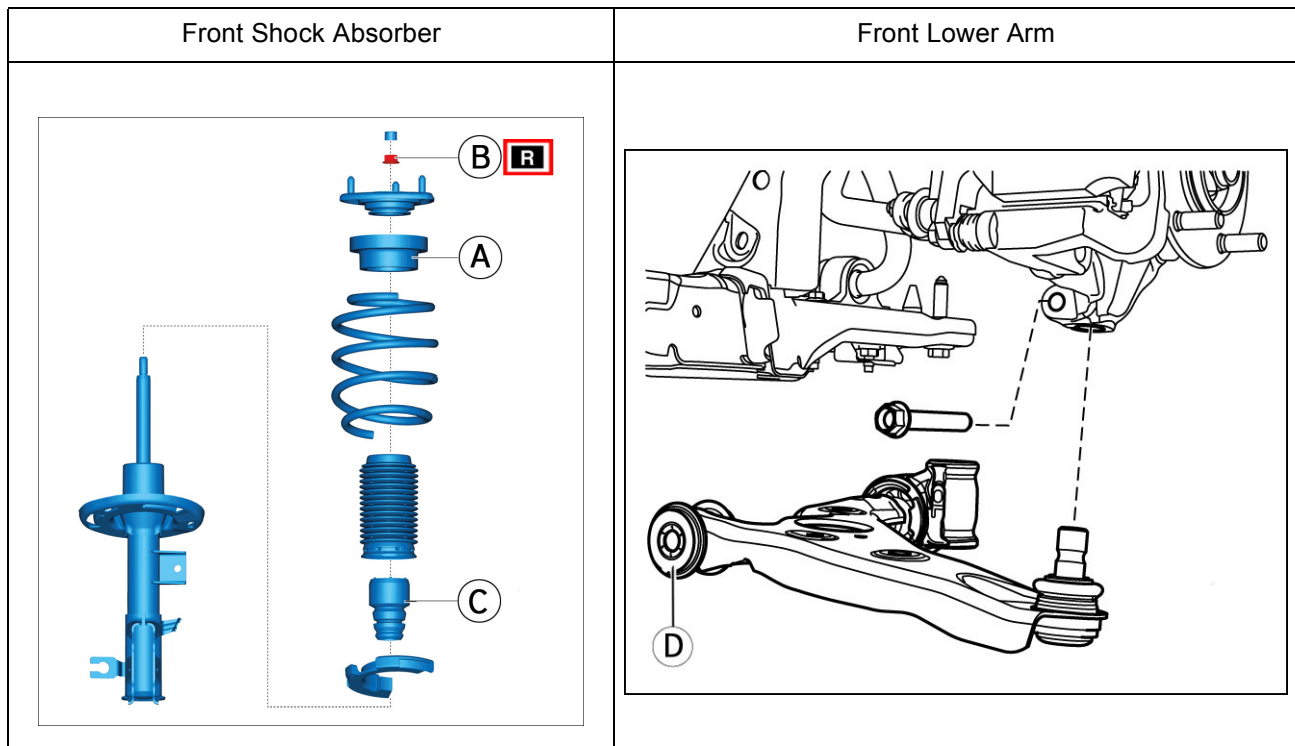
Some vehicles may exhibit a knocking / squeaking noise from the front shock absorber when driving on rough roads and/or when turning the steering wheel while the vehicle is stopped.

The noise may be due to:

- upper front strut bearing (A) damage. (CX-5 and Mazda6)
- stick/slip between the front strut bearing and coil spring. (CX-3, CX-5 and Mazda6)
- the bump stopper (C) may be contacting the strut bearing when the front shock absorber is compressed, causing a popping noise. (Mazda6 only)
- The front lower arm bushing (D) is making a stick-slip noise in wet road conditions. (CX-5 and Mazda6)

To eliminate the noise, the following mass-production changes have been made:

1. The material and production method of the front strut bearing (A) has been changed. (CX-5 and Mazda6)
2. A protector has been installed onto the coil spring. (CX-5 and Mazda6)
3. The shape of the bump stopper (C) will be modified in the future. (Mazda6 only)
4. The shape of the coil spring has been changed. (CX-3 only)
5. Friction of the lower arm bushing has been reduced by adding a dry coating. (CX-5 and Mazda6)

**NOTE:** The piston rod nut (B) requires replacement.

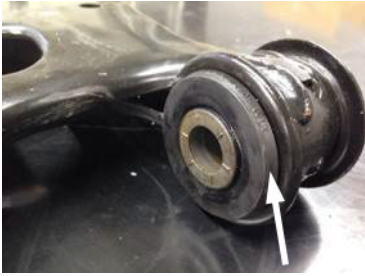
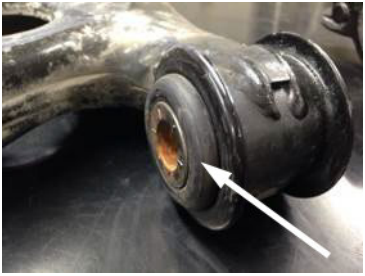
**CAUTION:** Make sure that the bushing has been properly inserted by checking that the tab of the bushing is completely expanded as shown in the OK illustration.

OK	NG
Tab is completely expanded	Tab is NOT completely expanded yet
