© 2015 Mazda Motor of America, Inc.

Subject: 2013-2014 CX-5 - VARIOUS ELECTRICAL SYSTEM MALFUNCTION(S) RELATED TO C-15 CONNECTOR CORROSION	Bulletin No: 09-041/15
	Last Issued: 10/14/2015

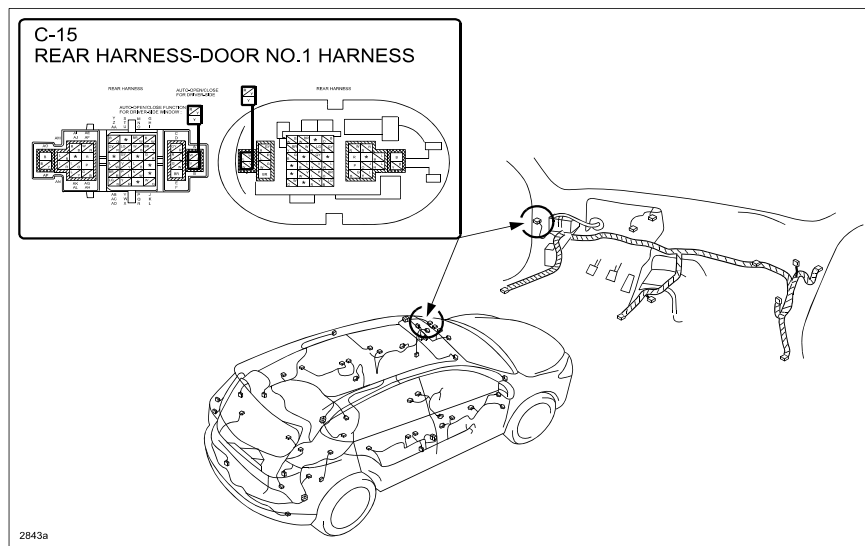
Some vehicles may experience one or more of the following symptoms in connection with a malfunction related to the C-15 connector.

- The driver side power window does not operate.
- The door does not open when using the advanced keyless system.
- The warning lamp stays ON even after the ignition switch is turned OFF.
- DTC B10E7:17 (START STOP UNIT, IG1 Relay Circuit Malfunction) and DTCs related to communication errors may be stored in PCM memory.

The symptoms listed above may be caused by corrosion of the C-15 connector terminals due to water intrusion through the front door. In low ambient temperatures, the door harness hardens. If the door is fully opened, it may create a gap between the door and the door harness grommet, which may allow water to enter through the gap.

If one or more of the above mentioned symptoms can be confirmed, disconnect the C-15 connector (which joins the door harness and the rear harness). Inspect for any signs of corrosion of the C-15 connector terminals referring to the inspection procedure below.

- If there is any corrosion at the C-15 connector, replace the door harness and repair the rear harness according to the following repair procedure.
 - If there is no corrosion found at the C-15 connector, this bulletin is not applicable. Troubleshoot the concern(s) according to the MS3 online instructions or the Workshop Manual.
1. Verify the customer concern.
 2. Record customers pre-set radio stations.
 3. Slide the driver side front seat fully backwards.
 4. Disconnect the negative battery cable.
 5. Disconnect the C-15 connector according to the MS3 online instructions or the Workshop Manual (section 09-11 FRONT DOOR REMOVAL/INSTALLATION).
 6. Inspect for any corrosion found on the terminals shown below.

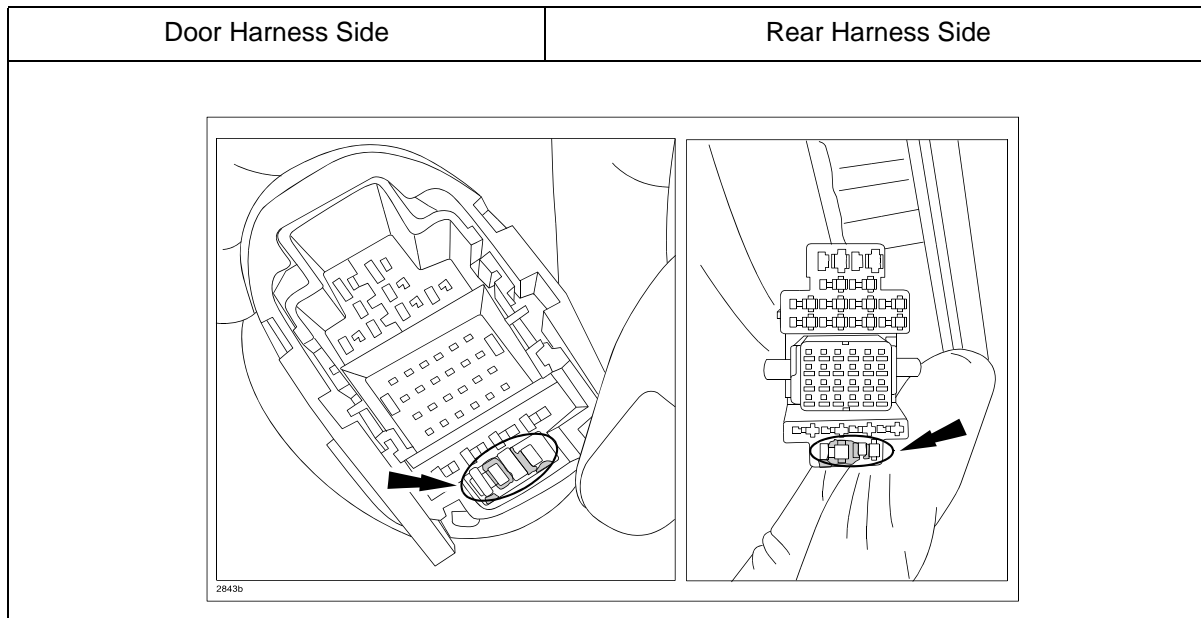
- If there is any corrosion found on the terminals, go to next step.
- If there is no corrosion found on the terminals, this bulletin is not applicable. Troubleshoot the concern(s) according to the MS3 online instructions or the Workshop Manual.
