Technical Service Handbook

Technical product information

Misfiring at high engine speed - 2.0 TFSI in TTS and S3

Release date: 30-Nov-2009

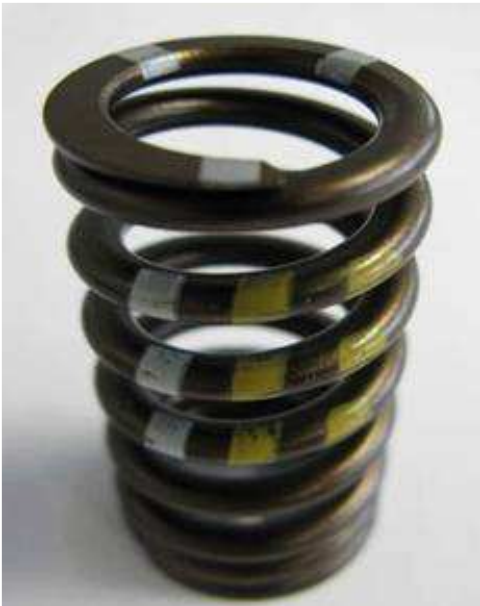
Engine judders or misfires at engine speeds over 5500 rpm.

Too soft valve springs.

Incorrect exhaust valve springs were fitted.

The colour marks of the incorrect springs are white/yellow (see photo).

Incorrect part - too soft valve springs:

If this spring is fitted, replace the exhaust valve springs according to the repair manual.

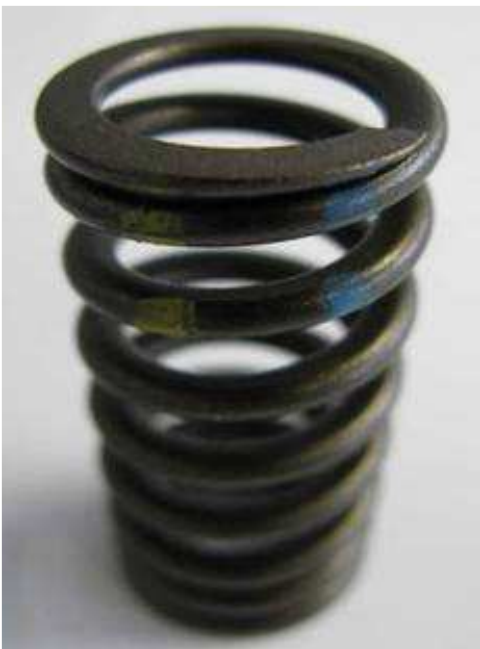
Correct valve spring:

Fit springs with Part No. 06F 109 623 with yellow/blue colour marks (see photo).
