SI B26 01 14
Driveshaft

March 2015
Technical Service

Service Action: Inspect Front Driveshaft

E70 (X5)

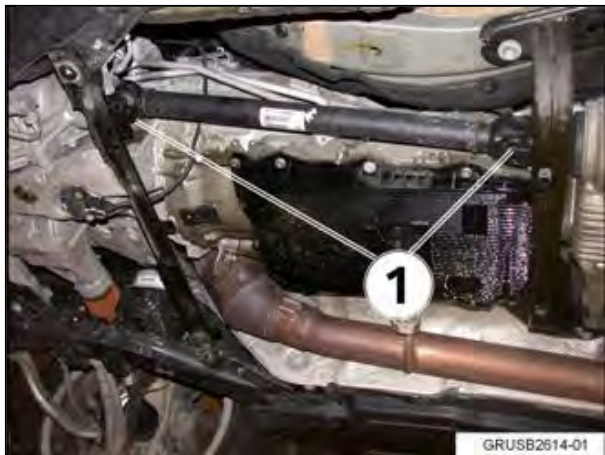
<p>Check the universal joints in the front driveshaft for radial play (1). Note: The E72 will need to have the reinforcement plate removed to check the driveshaft U-joints. Refer to Repair Instruction 31 10 010, "Removing and installing/replacing reinforcement plate."</p>
	<p>1. Checking the front U-joint:</p>
