SB-10054008-6314

SI B11 06 13
Engine

Service Action: Retrofit Bracket for EGR Cooler

E70 (xDrive35d)

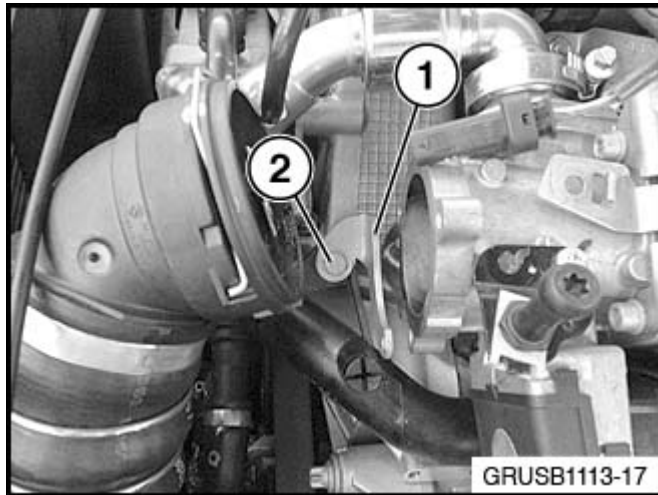
The flexible pipe on the high-pressure Exhaust Gas Recirculation (EGR) cooler may leak.

Excessive vibration and/or tension at the flexible elbow of the EGR cooler can cause it to leak.

<p>Install bracket P/N 13 54 8 576 446 (1) to the cylinder head using the bolt P/N 07 11 9 904 527 (2). Leave this bolt finger tight until after the throttle valve is reinstalled. NEW Note: If the EGR cooler is leaking at the flexible elbow, replacement is necessary.</p>
--	--
