SB-10045282-3617

SI B11 07 12
EngineNovember 2012
Technical Service

SUBJECT**N63 Engine: Oil Consumption and/or Rough Running Complaints****MODEL**

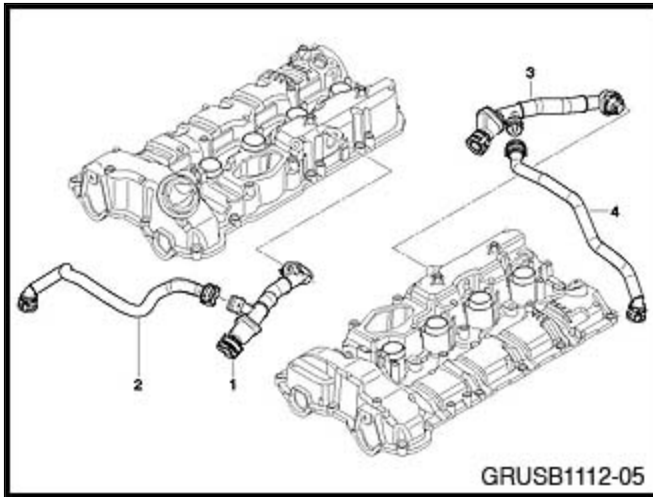
1. Remove the engine cover and inspect the crankcase ventilation connecting lines (1) and (3).

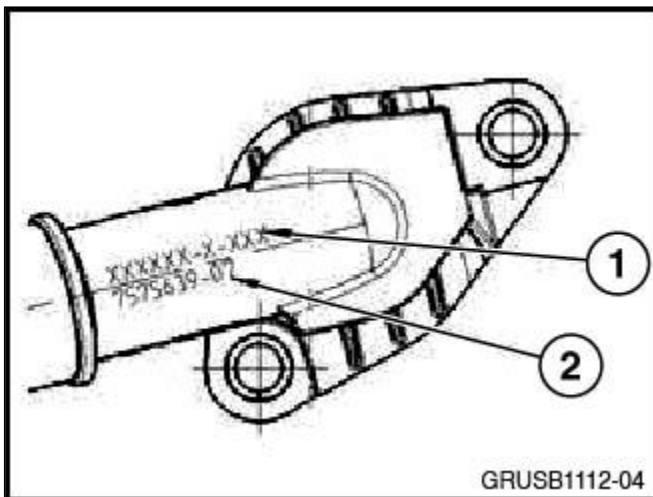
Each of the connecting lines will have an index number printed on the connection closest to the cylinder head cover.

2. Production code (1)

Part Number and Index Number
(2)

Example : 7575639-07

The index number is separated from the 7-digit part number by a hyphen. In this example, it is "07".

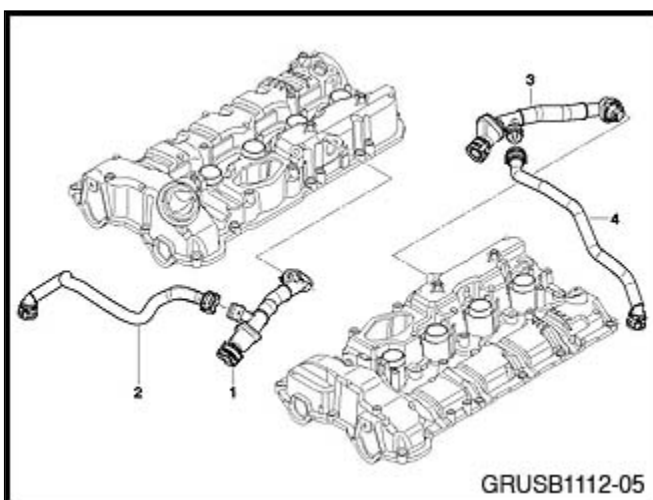
3. If the index number is "7" or lower, both crankcase ventilation connecting lines and vent pipes need to be replaced.

(1) Connecting line bank 1

(2) Vent pipe bank 1

(3) Connecting line bank 2

(4) Vent pipe bank 2

The improved replacement parts will have an index of "8" or higher.

4. Each cylinder head cover and vent pipe connection has two M6x18 screws attaching these components. The torque specification for these screws is 10 +/- 1.5 Nm.

Important: Do not replace the cylinder head covers for this complaint.
