SI B33 03 14
Rear Axle

SB-10056094-2346

Service Action/Delivery Stop: Rear Shock Absorber Guide Support

F15 (X5)

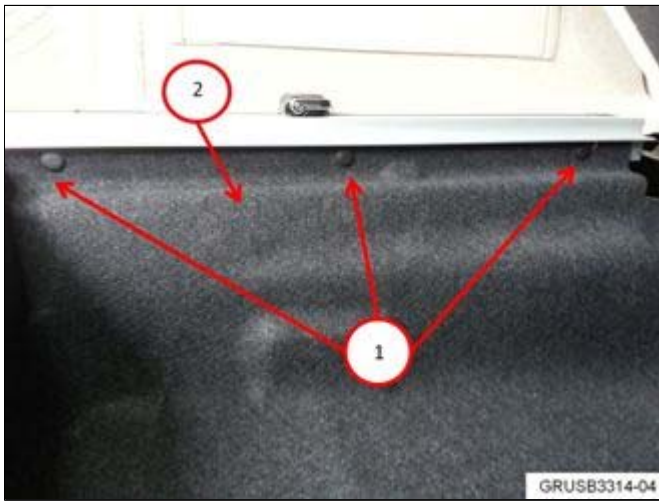
<p>Raise the luggage compartment floor. Remove the expanding rivets (1) from the left and right side of the luggage</p>
--	---

compartment pan (2) to expose the shock absorber guide support.

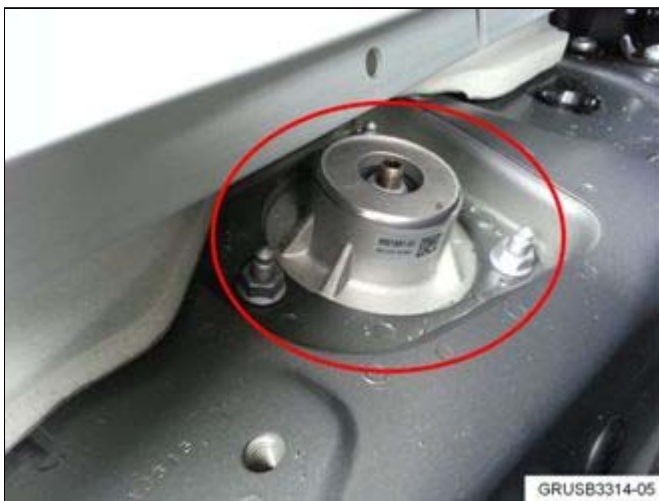
Check the parts label on the guide support.

NOTE: The left side of the luggage compartment is shown. It may be necessary to use an inspection mirror to identify the parts label on the right side guide support.

If the incorrect guide support is installed, replace it per Repair Instruction 33 52 161.

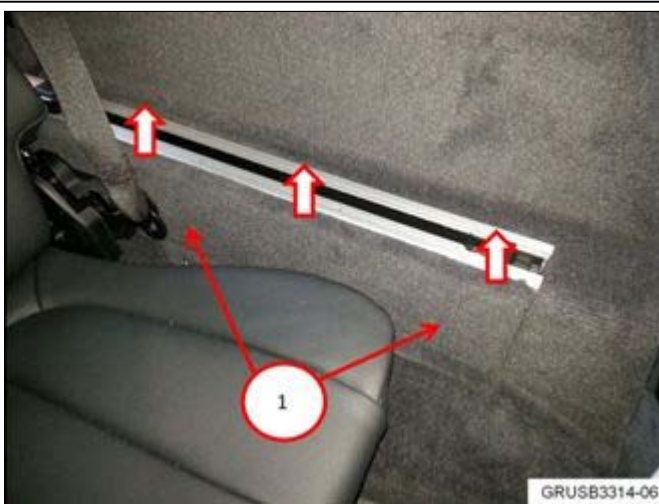
Fold out the third seat row to gain access to the bottom left and right trim panel (1).

Detach the trim panel (1) from the retainers towards the top.

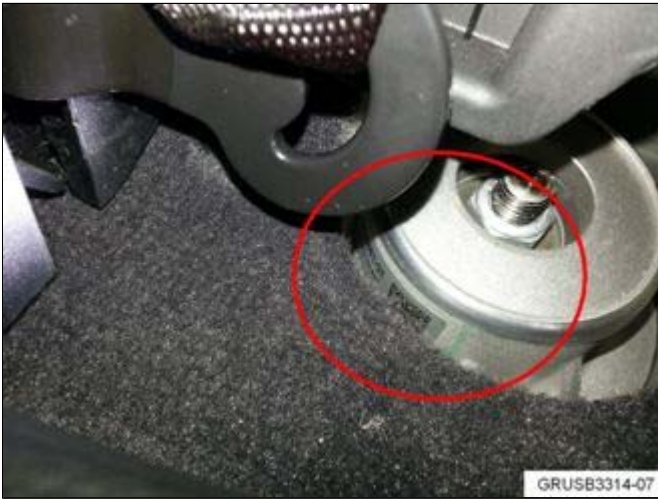
Check the parts label on the guide support.

NOTE: The left side of the luggage

compartment is shown. It may be necessary to use an inspection mirror to identify the parts label on the right side guide support.

If the incorrect guide support is installed, replace it per Repair Instruction 33 52 161.
