Topic	V8T- Alternator - Water deflection shield (SC13/13)
Market area	Worldwide Bentley (1WBE)
Brand	Bentley
Transaction No.	2033404/1
Campaign number	E789
Note	
Type	
US code

New Continental GT V8 and GTC V8

V8T- Alternator - Water deflection shield (SC13/13)

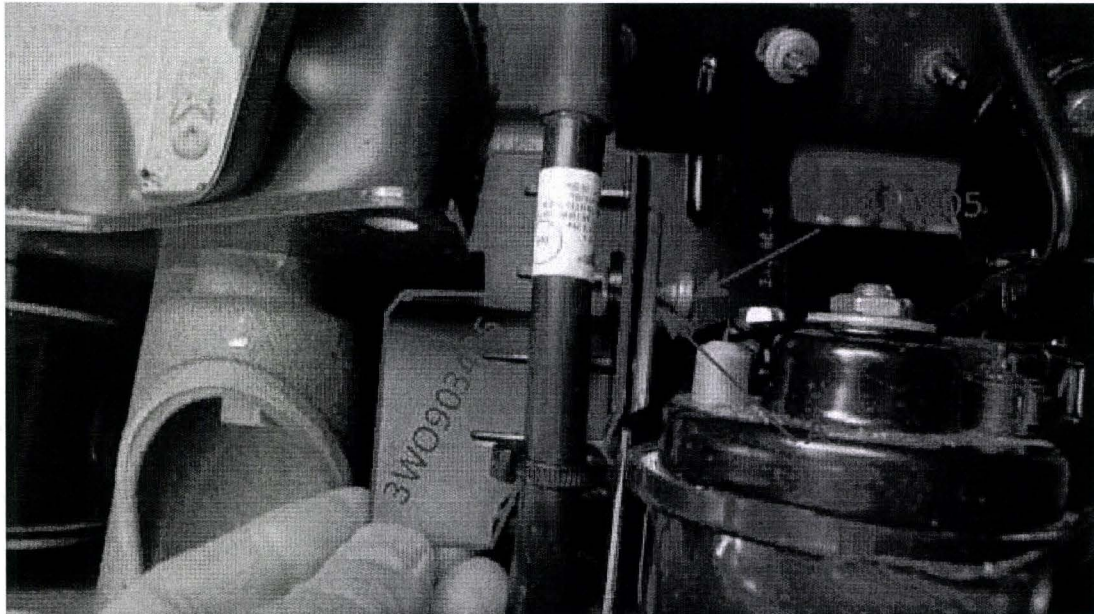
Figure 1

Water entering the engine bay via the right hand front wheel arch liner slats can contact the rear of the alternator and may lead to corrosion on the alternator main output terminal. To minimise the potential for water to contact the rear of the alternator a water deflection shield has been developed and is now fitted during manufacture.

4. Referencing figure 1 fit the new splash shield part number 3W0903445 to the original horn support bracket utilising the existing hole (A). Secure the new shield with M6 screw N10451405. Tighten

M6 screw to 6Nm

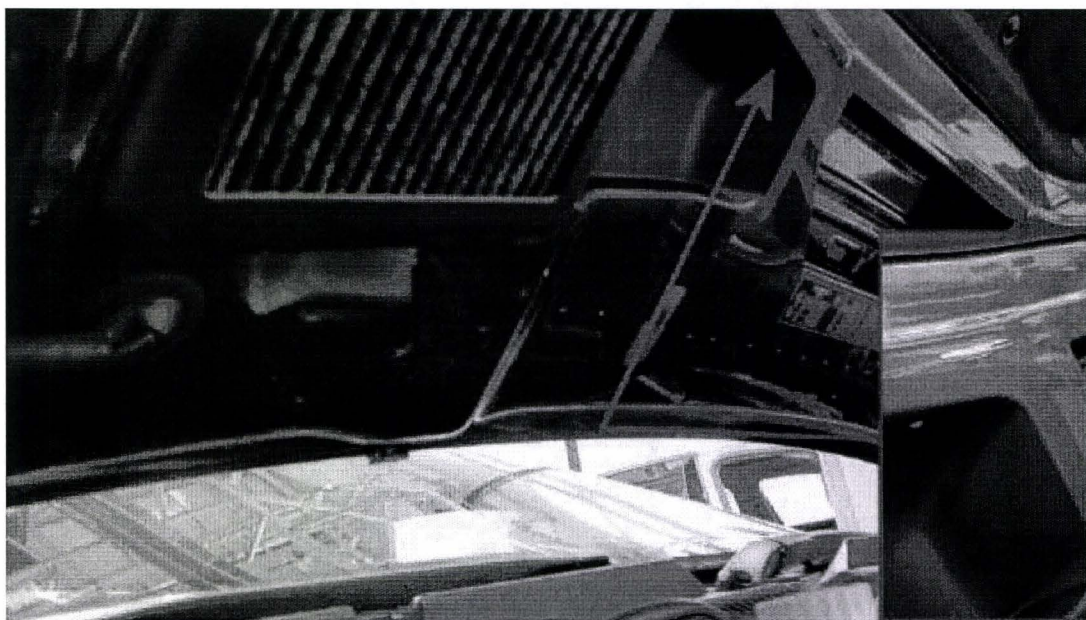
Figure 2

Yellow paint completion mark on Right hand pollen filter housing

If the vehicle is not already listed as repaired in the "Repair history" (in Elsa pro), check for the campaign identification mark, yellow paint mark on right hand pollen filter housing (Figure 2), should neither be evident carry out the required work in accordance with these instructions
