# Technical product information

Topic	8 speed transmission - front differential noi					
Market area	Worldwide Bentley (1WBE)					
Brand	Bentley					
Transaction No.	2032542/1					
Level	EH					
Status	Approval					
Release date

## Continental V8T and New GT Speed

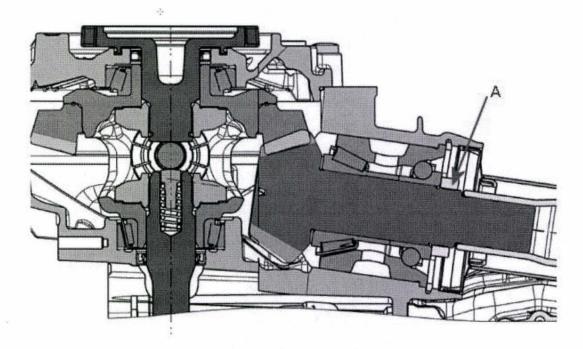
A small number of 8 speed transmissions have developed a front differential noise in service. Subsequent investigations of these replaced units identified a reduction in the torque of the nut (A) retaining the front differential bevel gear bearing. Front differentials where the clamping load on this bearing has relaxed will become noisy and have a greatly reduced service life

The surface finish and method of locking the bevel gear bearing retaining nut has been changed

As the front axle final drive unit is not serviceable and is integral with the main transmission assembly a qualified complaint of this nature can only be rectified by fitting a new transmission assembly.
