Technical Service Bulletin

Topic	Mulsanne - 8 Speed Transmission - Harsh Gear Shift
Market area	Worldwide Bentley (1WBE)
Brand	Bentley
Transaction No.	2035309/2
Level	EH
Status	Released for publishing
Release date	Dec 9, 2013

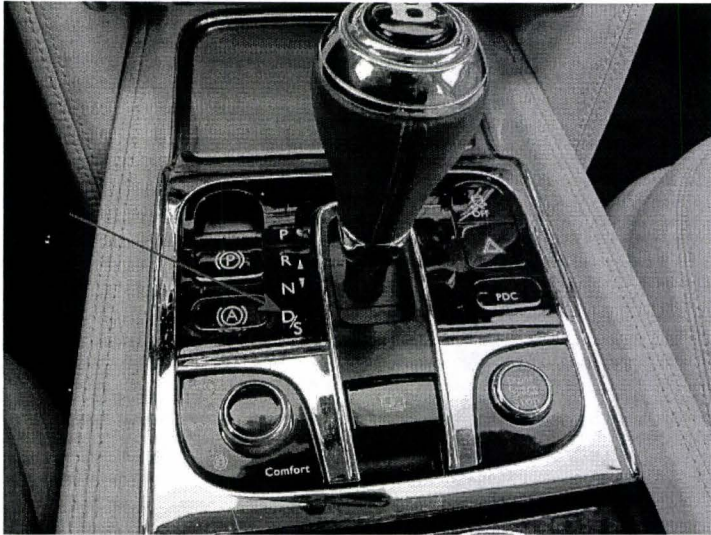
Figure 1

The gear shift performance when in 'D' mode (Figure 1) is harsh and not smooth as expected.

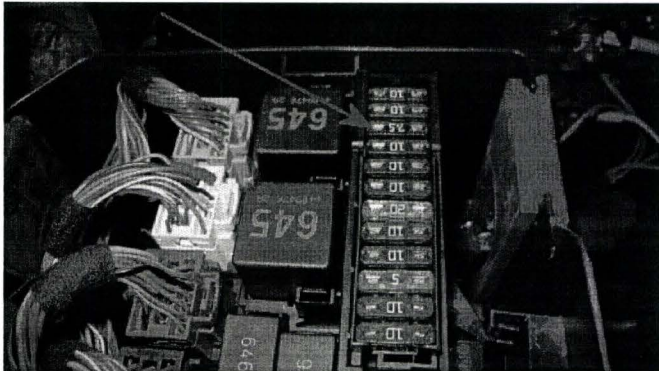
Figure 7

The (CDA) cylinder deactivation fuse must be removed during the transmission adaptations process to enable the adaption process to fully complete in particular clutch B

- Remove the fuse box lid and remove the CDA fuse which is the 7.5 Amp fuse (number 3) which is positioned towards the rear of the fuse box (Figure 7) **IMPORTANT:** Please leave the fuse out until instructed to refit later in the TPI
