### Field campaign

<b>Topic</b>	V8T cold start valve coolant leak (SC12/05)
<b>Market area</b>	Worldwide Bentley (1WBE)
<b>Brand</b>	Bentley
<b>Transaction No.</b>	2030588/1
<b>Campaign number</b>	E765
<b>Note</b>	
<b>Type</b>	
<b>US code</b>

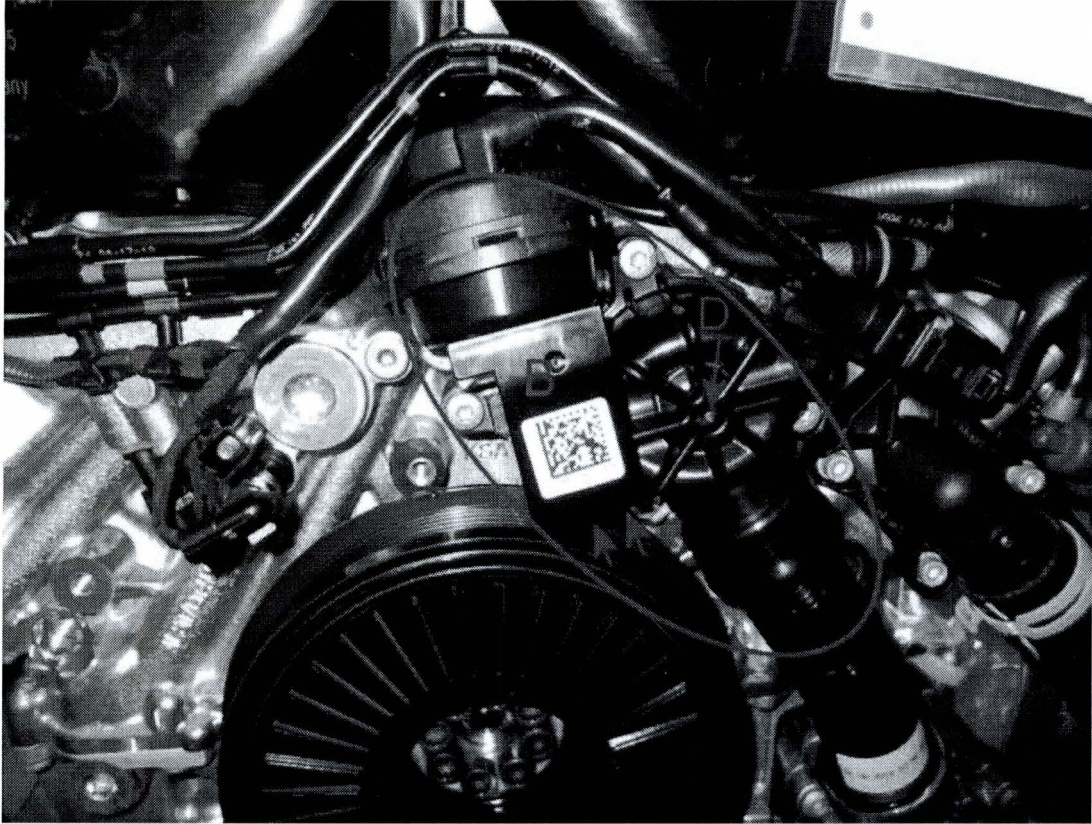
Figure 1

1. Locate the coolant warm up valve assembly (B). It is incorporated into the main engine coolant system and positioned adjacent to the crankshaft pulley, it is fitted with a distinctive bar code label (see Figure 1)

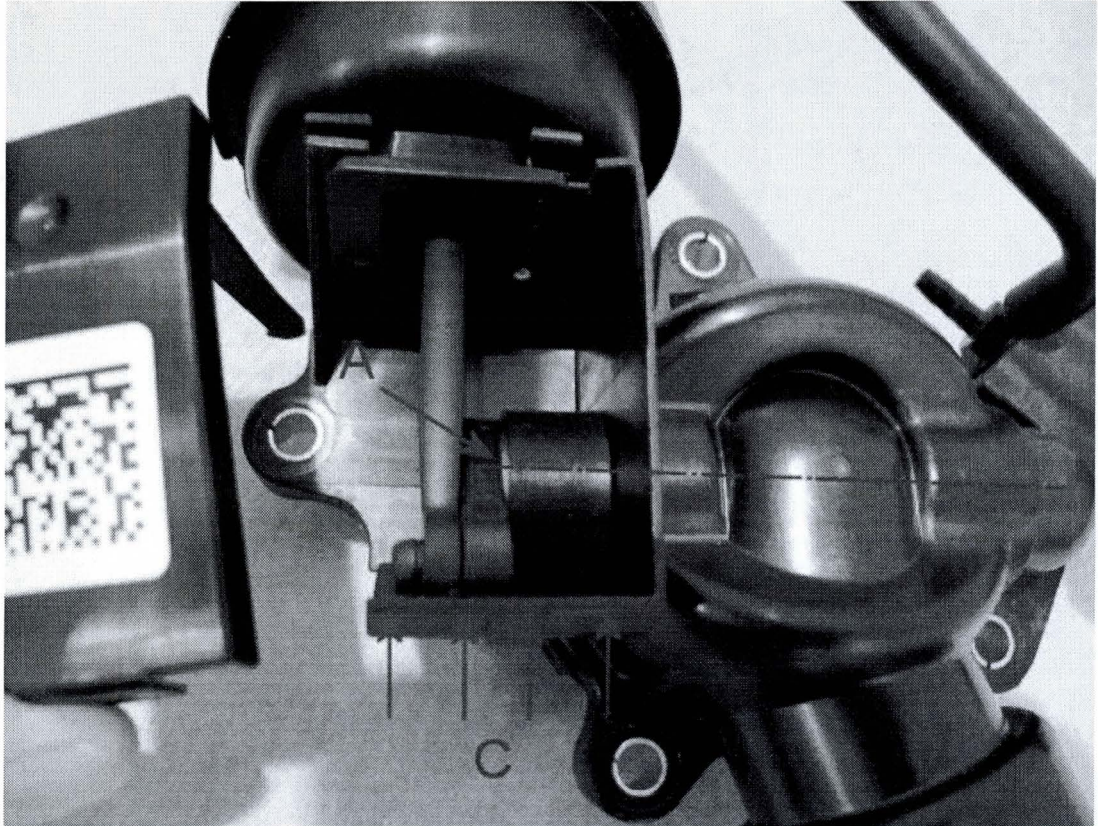
2. If the seal is leaking it will discharge a small amount of coolant from the valve spindle (A) into the actuating arm housing, this will subsequently be visible on the outside lower edge of the housing cover at point 'C'. Figure 2 shows the actuating arm housing cover removed. This is to aid understanding and clearly describe the leak path. It is not a requirement of this procedure to remove this cover. Note: the valve body in figure 2 is not fully representative of the series production part.

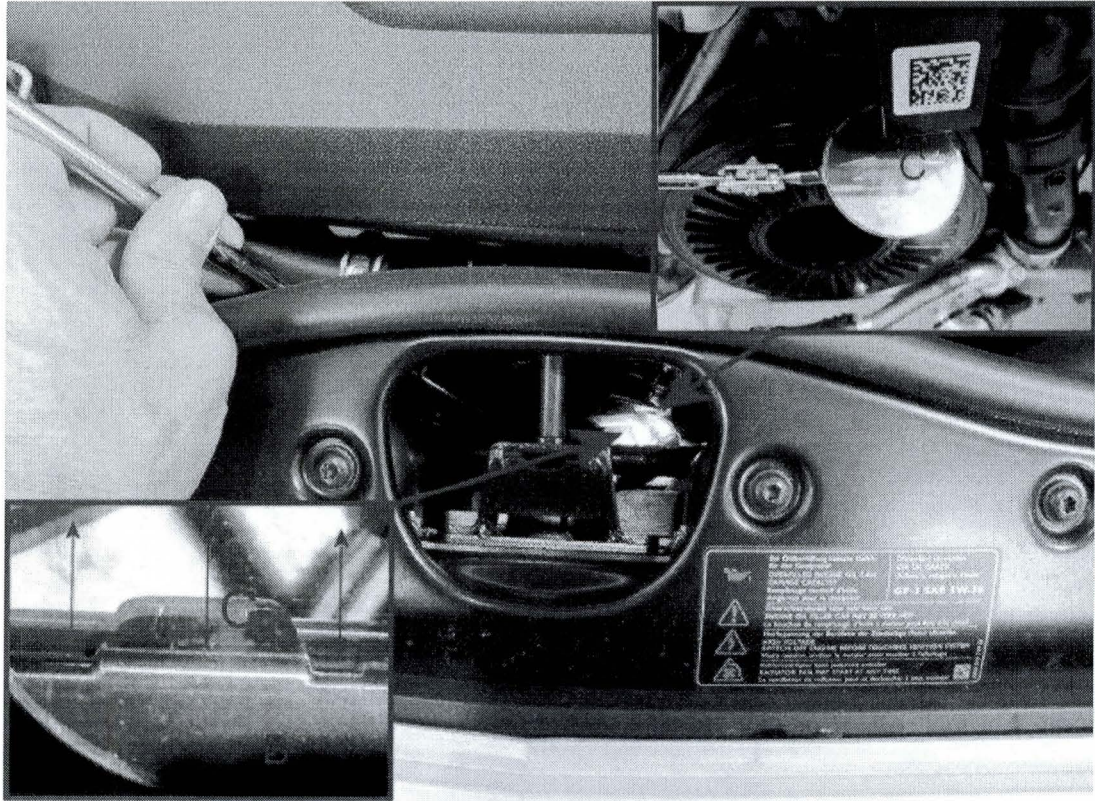
Figure 3

3. The initial inspection is carried out using a mirror. Note: no parts have to be removed for the inspection. Position the mirror so as to enable the underside of the lower edge of the housing cover (B) to be viewed at point 'C'. Check for the presence of coolant on this face (see Figure 2 and 3)
4. If there is any evidence of this component leaking coolant then spray the area with cleaning fluid to remove the coolant residue before carrying out the repeated cycle procedure detailed in the flow chart. If no coolant leak is evident on first inspection the flow chart procedure must still be performed. This test will initially expose the valve to the condition in which a valve with the incorrectly fitted seal will leak, then by continued cycling in a controlled environment will correctly position a misplaced seal, resulting in a serviceable component.
