Transaction No.: 2032874/1

Continental Series - W12 Engine - Bank 2 Deflection pulley noisy

Release date: 16-Apr-2013

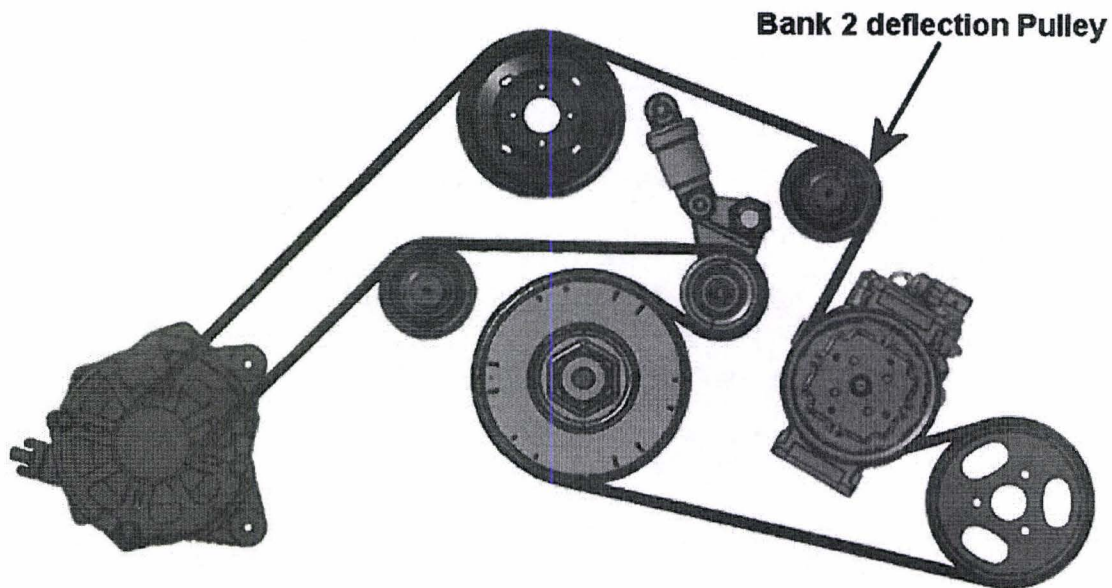
Figure 1

In the event that the Bank 2 accessory drive belt deflection pulley (Figure 1) is diagnosed as unserviceable/noisy leading to the pulley requiring replacement, please commence with this TPI.

Replace the Bank 2 accessory drive belt deflection pulley - Refer to Workshop Manual Rep.Gr 13 - Accessory Drive Belt Deflection Pulley - Bank 2 - To Replace **NOTE:** The torque for the latest specification deflection pulley fixing (Figure 6) is 40 Nm + 90 degrees and refit the dust cap

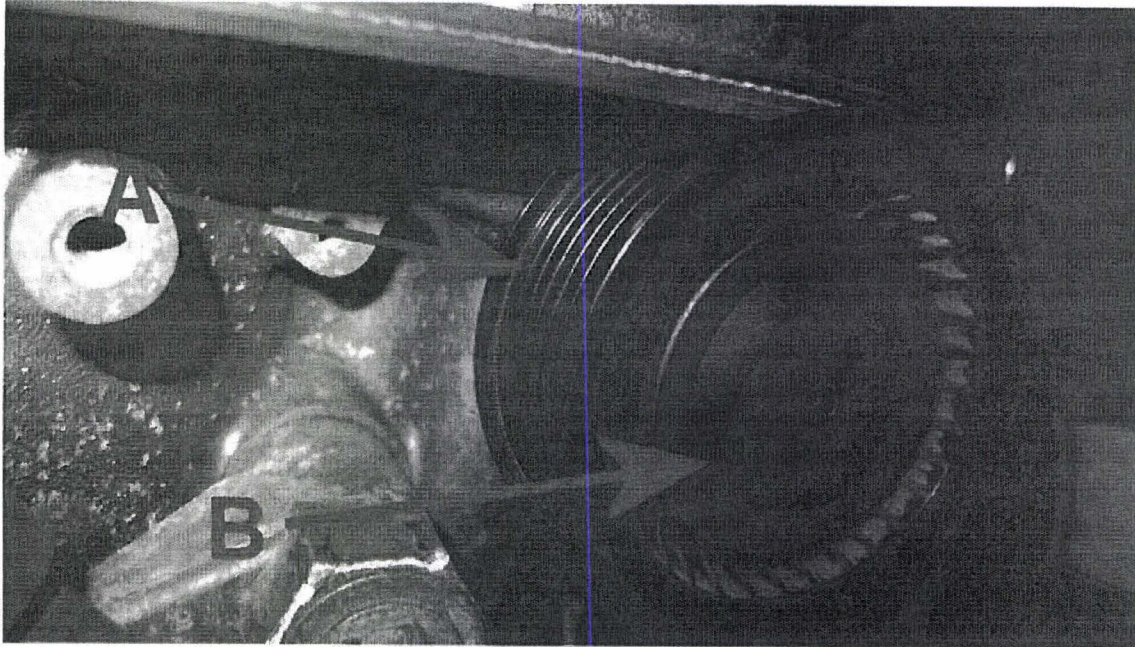
Figure 2

- The original pulley operated using a single row ball bearing
- The original specification single row pulley can be identified as it has a grooved belt running surface (Figure 2 point A) and also a shallow cone shaped dust cap (Figure 2 point B)
- The original pulley is secured with a Torx bolt as shown in Figure 3

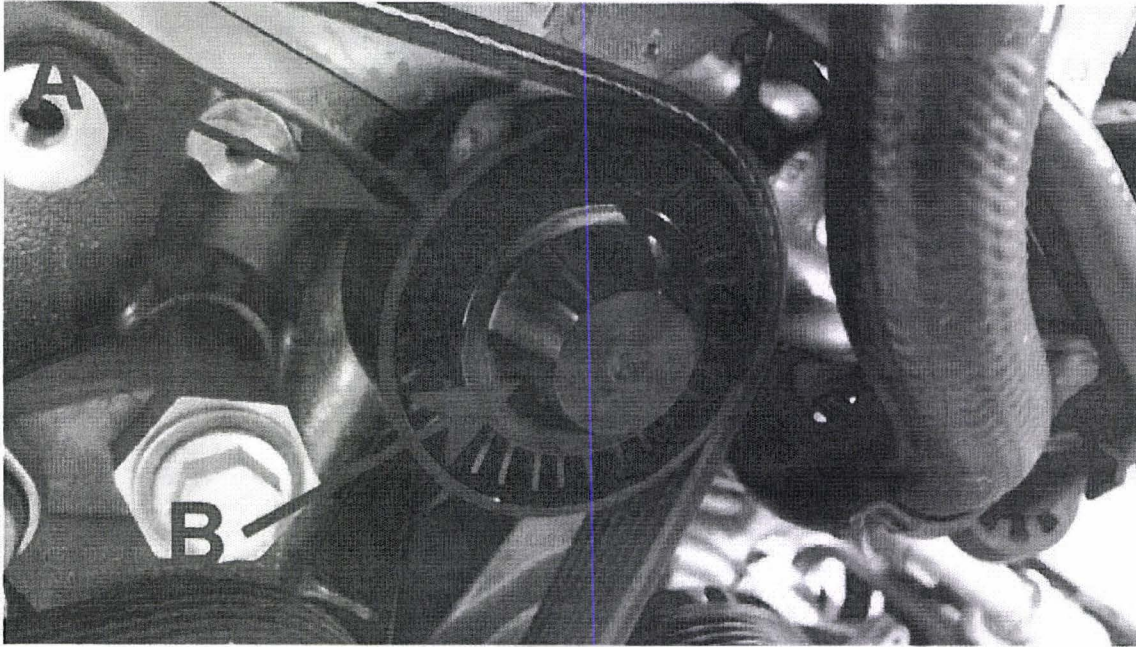
Figure 4

- The latest specification part now operates using a double row ball bearing
- The pulley can be identified as is has a smooth belt running surface (Figure 4 point A) and a deep cone shaped dust cap (Figure 4 point B)

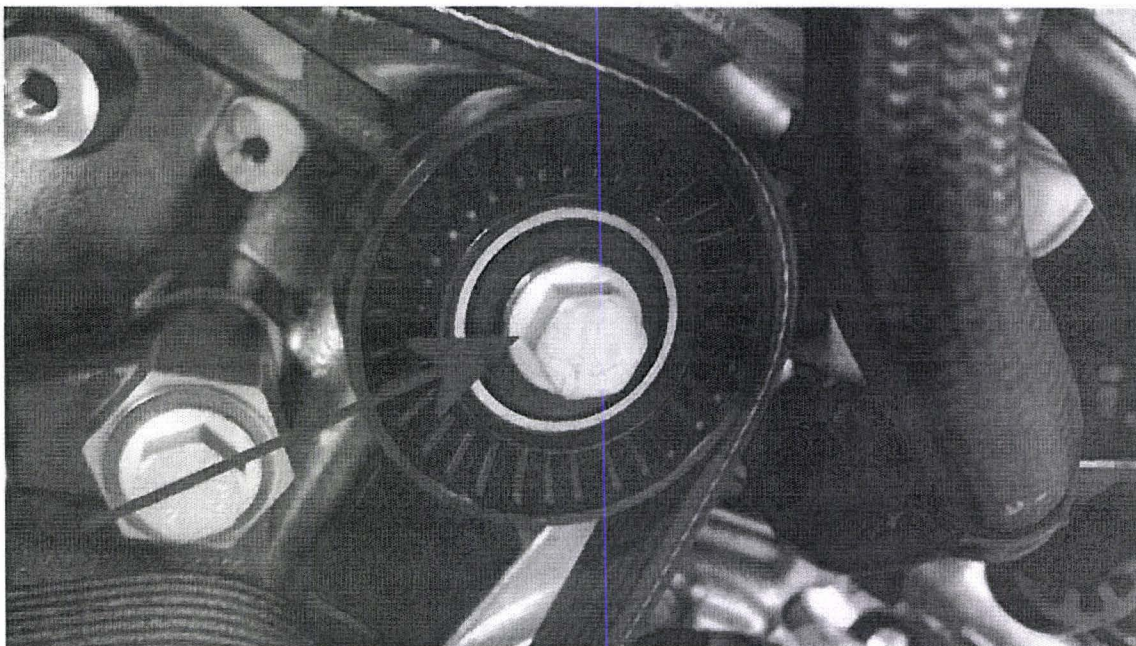
Figure 5

-The new specification pulley is now supplied and secured with a 16mm Hexagon headed bolt (Figure 5) Do not under any circumstances use any other fixing other than the new 16 mm Hexagon headed bolt supplied with the latest specification pulley
