**NUMBER:** 23-052-05

Rear Fascia To Body Side/Tail Lamp Fit

This bulletin involves adding two nut and bolt attachments to the rear fascia.

2005 - 2006 (LX/LE) 300/Charger

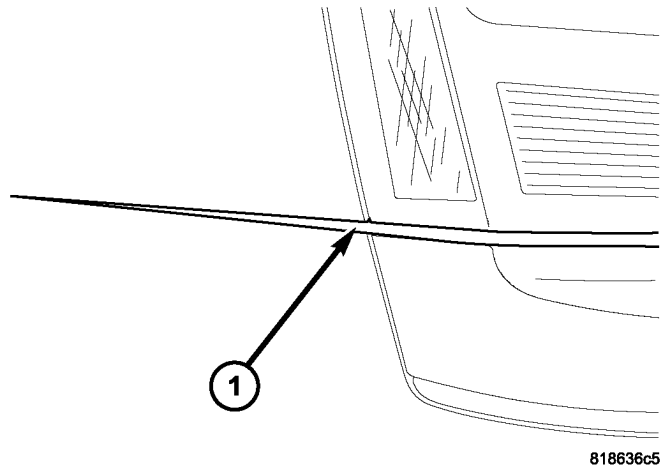
**Fig. 1 FASCIA TO BODE SIDE/TAIL LAMP GAP**

The gap between rear fascia and body side/tail lamp is more than 2mm (5/64 in).

If gap between rear fascia and body side/tail lamp measures more than 2mm (5/64 in), ([Fig. 1](#)), perform the Repair Procedure.

1 - GAP SHOWN GRATER THAN 2MM (5/64 IN.)

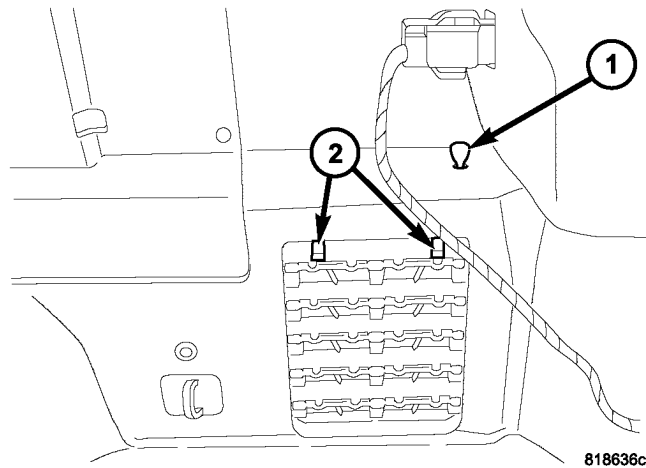
**Fig. 2 PUSH PIN LOCATION**

- 1 - PUSH PIN
- 2 - EXHAUSTER RETAINER TABS

1. Open the trunk lid.
2. Pull the trunk carpet away from one side of the trunk.
3. Remove the push pin (located above and rearward of the body exhauster) attaching the fascia to the body side, by pushing out the center (white) pin with a punch, then push (black) body through hole, (Fig. 2). Pin and body will fall to the ground under the rear fascia.

4. Apply a drop of MOPAR Lock & Seal Adhesive, p/n 04318031, to the threads of bolt, p/n 06505546AA.
5. Insert bolt, p/n 06505546AA, downward through the push pin hole.
6. Remove the body air exhauster by pushing down on the retaining tabs, and pushing the exhauster through opening.
7. Hand start nut, p/n 06104726AB, onto the bolt through the exhauster opening.
8. Tighten the nut and bolt to 11 Nm (100 in. lbs.).
9. Install the body air exhauster.
10. Return the trunk side carpet to its original position.
11. Repeat steps 2-10 for the other side repair.
12. Close the trunk lid.
