NUMBER: 02-001-13
GROUP: Front Suspension
DATE: March 06, 2013

Noise From Front Of Vehicle Over Bumps Or When Turning

2012-2013 (JC) Journey

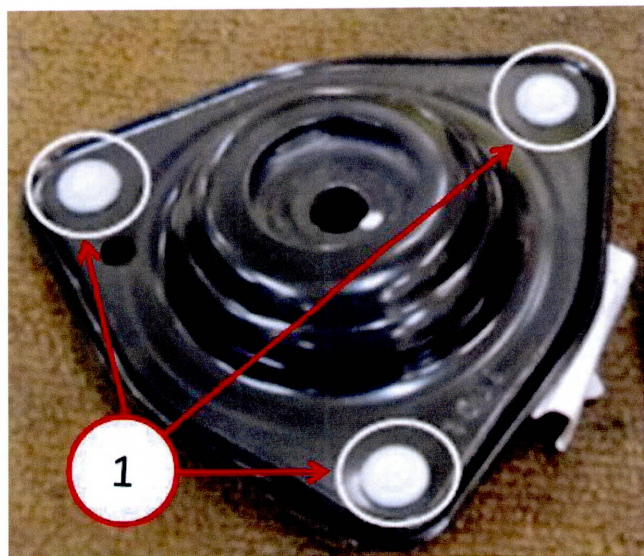
Fig. 1 Front upper Strut Bracket

1 - Stud Heads

NOTE: Assemble the upper front mount strut bracket (**Fig. 1**) to the upper front strut bearing (**Fig. 2**) by aligning the stud heads on the strut bracket to the 3 notches on the strut bearing.

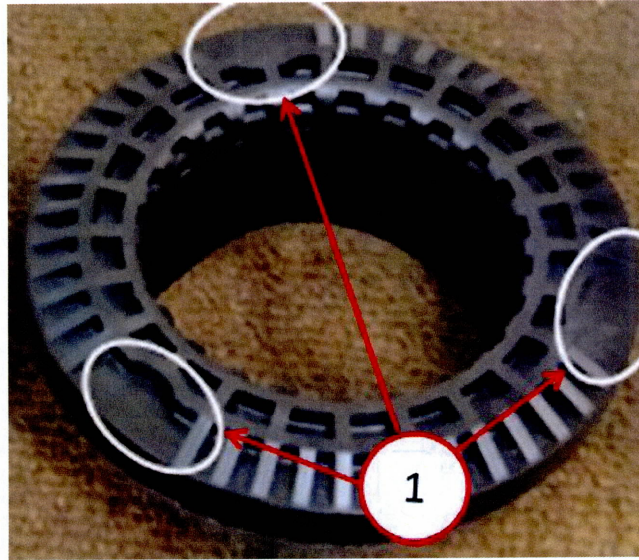
Fig. 2 Front Upper Strut Bearing

1 - Notches
