**SUBJECT: DEMONSTRATION / DELIVERY HOLD - Safety Recall 14S17**

Certain 2013 and 2014 Model Year Focus ST and Escape Vehicles Equipped with a 2.0L Engine  
Engine Wiring Splice Repair

## CERTAIN 2013 AND 2014 MODEL YEAR ESCAPE VEHICLES EQUIPPED WITH A 2.0L ENGINE — ENGINE WIRING SPLICE REPAIR

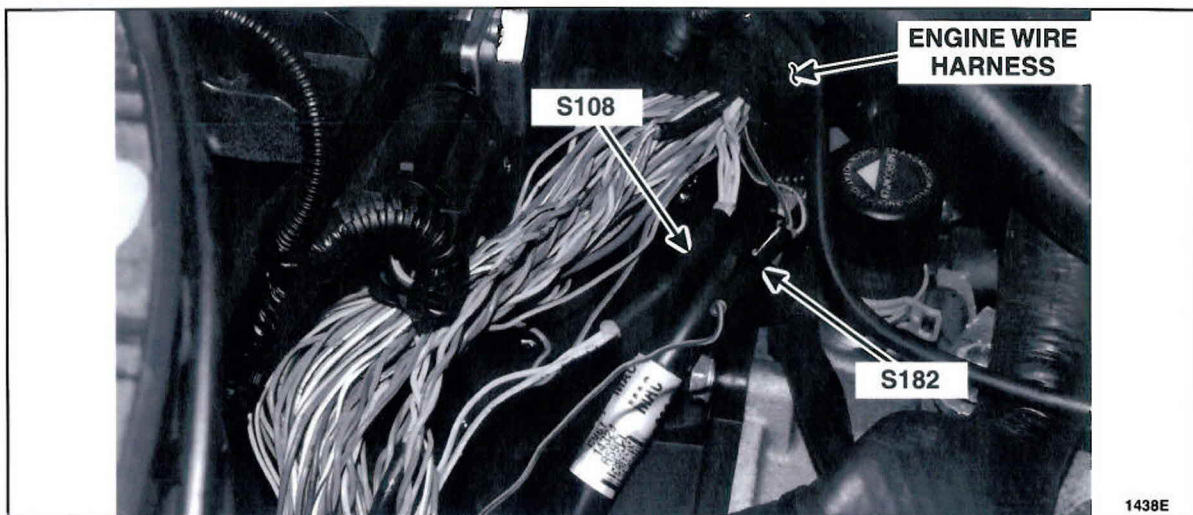
**FIGURE 6**

- S182 is a one (1) wire into two (2) wire splice with Gray/Brown wires.
- S108 is a two (2) wire into four (4) wire splice with Yellow/Green wires.

10. Locate splice S182 and S108. See Figure 6.
