Applies To: **See VEHICLES AFFECTED**

May 21, 2009

## Convertible Top Is Torn at the Lock Handle and/or the Right Rear

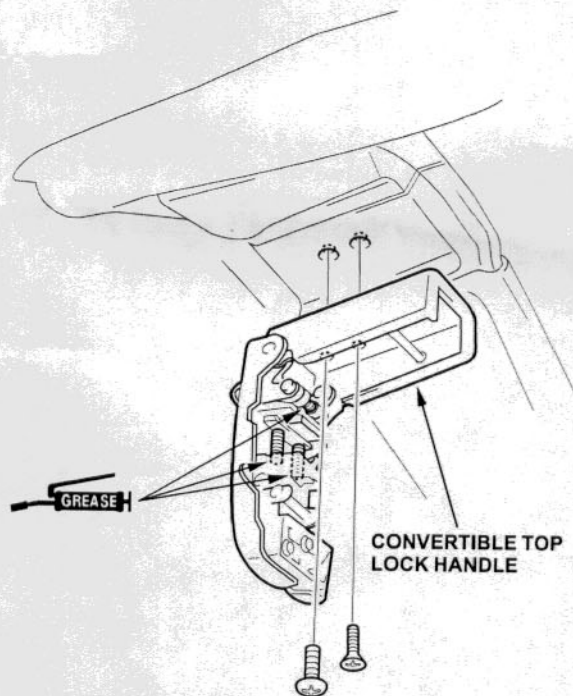
6. Remove the lock handle on the affected side(s) as shown.

7. Install the handle(s) in the reverse order of removal, and apply multipurpose grease to its springs and moving parts. Then, go to step 11.

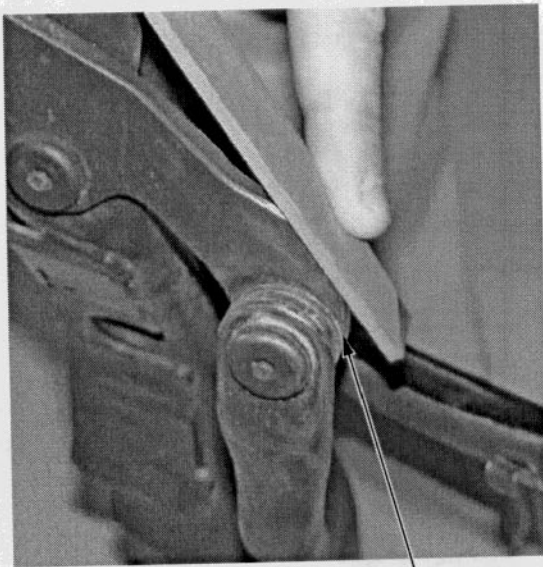
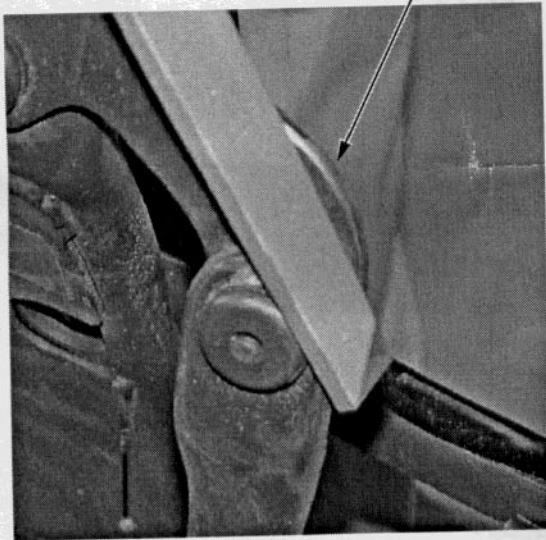
FRAME HINGE

8. Locate the burrs at the right-rear of the frame hinge, then use a file to remove the burrs and any rough areas.

Remove all the burrs.

9. Remove all metal particles from the hinge and the frame.

10. Prime the filed area with a commercially available primer spray paint, and allow it to dry. Finish the primed area with a flat black spray paint.
