Technical Service Bulletin

NO.
12-20-004

SUBJECT
ACCENT EXHAUST RATTLE – FRONT MUFFLER BRACKET REPLACEMENT

MODEL
ACCENT (MC)

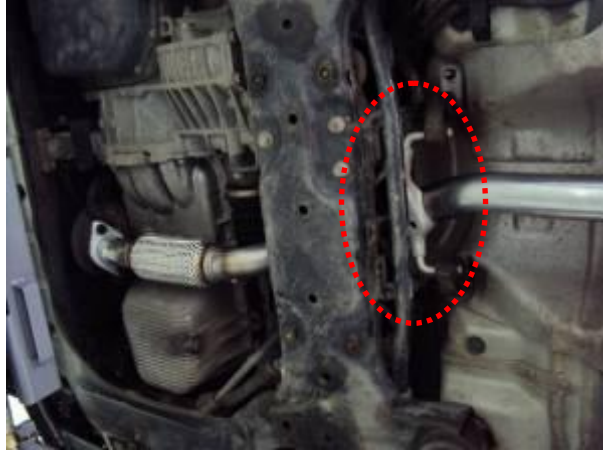
1. Raise the vehicle on a lift.
2. Locate the front muffler pipe hanger bracket.

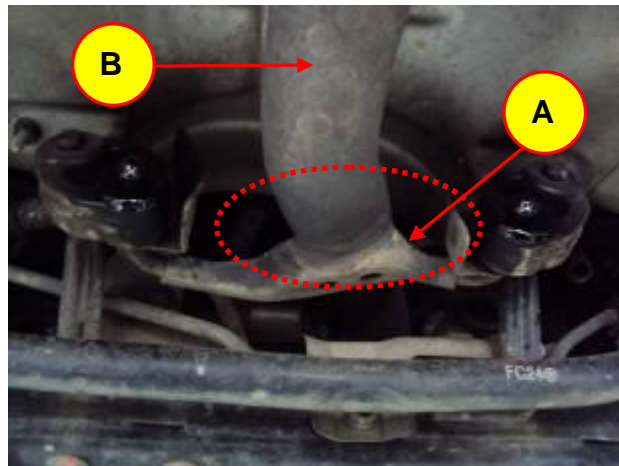
3. Inspect the weld (A) between the exhaust pipe (B) and the bracket.
 - 3-1. If the bracket has completely separated from the exhaust pipe, proceed to service procedure #1 to replace the front muffler bracket.
 - 3-2. If the bracket is not separated from the exhaust pipe inspect the front exhaust pipe for holes. If none are found cut off the bracket and proceed to service procedure #1. If holes are found in the exhaust pipe proceed to service procedure #2 to replace the front muffler assembly.
