**S-TYPE**

S303-S145

SERVICE**TECHNICAL BULLETIN**

Coolant Level Sensor Contamination –
Disable Sensor –
Service Action S145

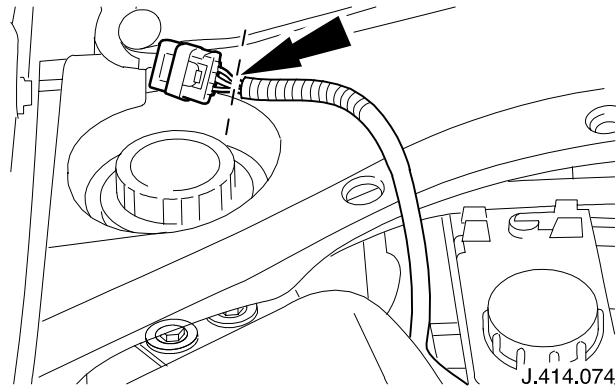
ILLUSTRATION 3

CUT CABLE CLOSE TO CONNECTOR

7. Reposition sensor connector plug lead for access and cut sensor cable as close to connector as possible and discard connector (Illustration 3).
8. Release plenum finisher.
9. Reposition sensor cable forward from plenum area into engine bay.

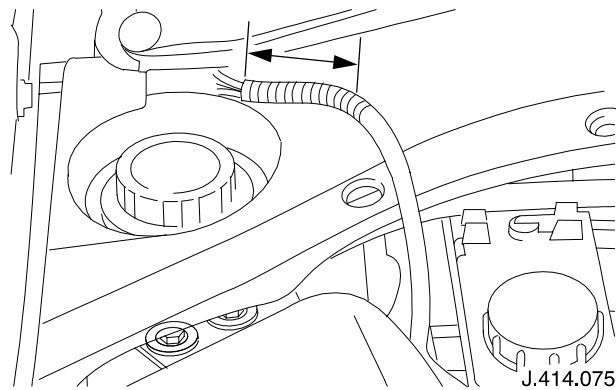
ILLUSTRATION 4

STRIP BACK CABLE WRAPPING

10. Strip back sensor cable tape wrapping and convoluted tubing to approximately 60 mm back from end of cable (Illustration 4).
11. Fit heat shrink tube (418-104) from harness repair kit halfway onto end of each cut wire.
12. Using a suitable hot air gun, shrink tubing onto each wire.
13. Using a suitable tool, squeeze to seal each end of heat shrink tubing before sealant sets.
