S303-S159

**SERVICE****TECHNICAL BULLETIN**

Engine In Limp Home/Check Engine MIL –  
Water Ingress into Throttle Position Sensor –  
Service Action S159

MODEL 2003-04 MY  
S-TYPE R

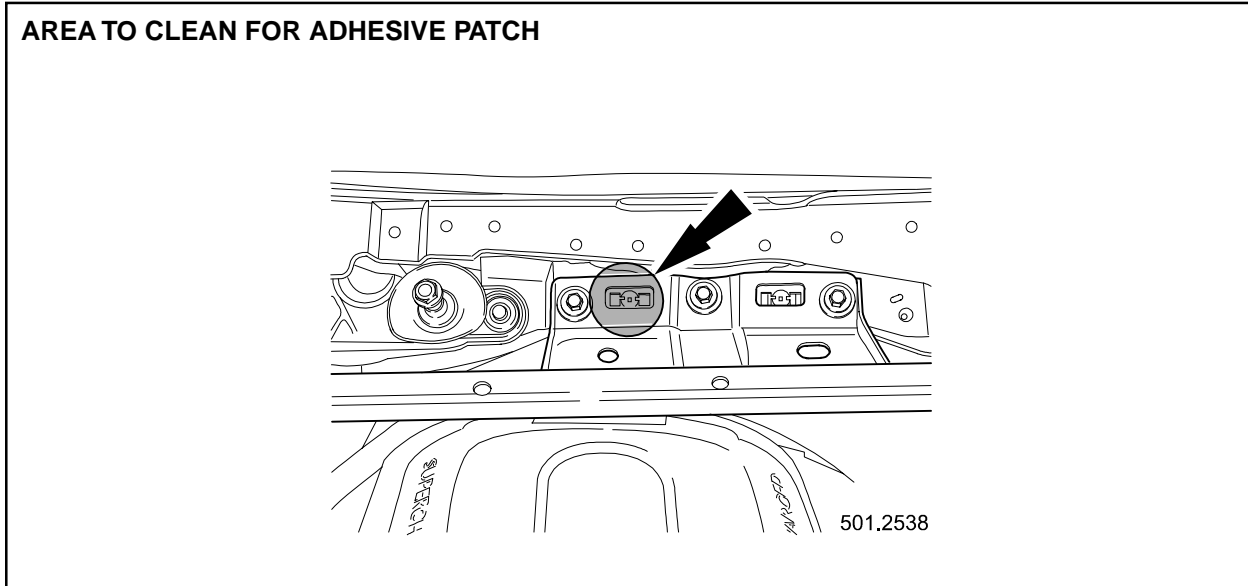
ILLUSTRATION 1

- Clean the area indicated on the bracket of the suspension turret cross brace where it secures to the bulkhead (Illustration 1).

- Ensure the plastic insert is central in the rectangular hole of the brace.
- Remove and discard the backing from the adhesive patch and install the patch centrally over the right hand rearmost rectangular hole (Illustration 1) of the suspension turret cross brace.
- Reinstall the cowl panel grille, see Workshop Manual, JTIS CD ROM, section: 501-02, SRO 76.10.01.
- Remove fender protection kit and close hood and door.
