**Water Leakage Into Rear Footwells –  
 Add Drain Holes –  
 Modification Procedure**

MODEL 2000-01 MY  
 S-TYPE

VIN L00001-L86901

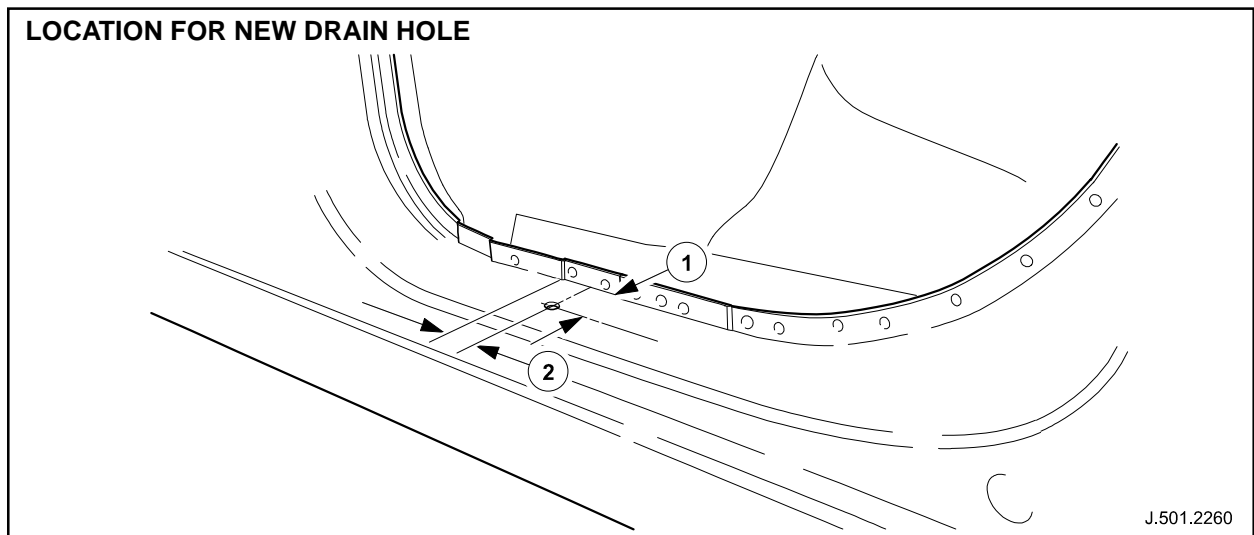
ILLUSTRATION 1

Some S-TYPE vehicles within the above VIN range may experience water leaking into the rear footwells during/after heavy rainfall. This is caused by water entering the inner door panel section via the door latch. This water is unable to drain away because the secondary door seal traps the water on the inner door aperture sill panel. To eliminate this, a procedure has been developed that involves drilling a drain hole. This modification entered production from VIN L86902.

1. Working on left side of vehicle, remove rear door aperture seal from sill flange.
2. Clean sill top surface with suitable cleaning agent.
3. Apply masking tape to area of sill to be drilled.
4. Measure from the third spot weld depression in the sill aperture flange 32.5 mm from the flange face across the sill, and draw a line on the masking tape (1, Illustration 1).
5. Measure from the third depression in the sill aperture flange 30 mm to the rear of the car and draw a line on the masking tape to cross the line drawn in step 4 (2, Illustration 1).

6. Drill 3mm diameter pilot hole at marked position, then drill final hole to 8mm diameter.
7. Carefully remove drilling swarf.
8. Remove and discard masking tape.
9. Carefully de-burr drilled hole.
10. Apply suitable zinc enriched paint to bare metal of drilled hole and allow to dry.
11. Smear suitable silicone grease to edge of drilled hole.
