# TECHNICAL BULLETIN

No: JTB00066  
Issue: 3  
Date: 14 MAY 2010

## Ticking / Bubbling Noise From Behind Fascia / Instrument Panel

S-TYPE (X200)

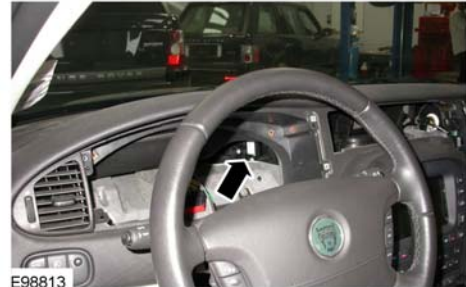
Figure 1

**Situation:** A ticking or bubbling noise may be heard coming from behind the fascia / instrument panel when using the climate control system. The noise may be the result of one or more of the climate control blend door actuators giving incorrect position feedback to the climate control module, causing the blend doors to continually search for their correct position and causing the noise.

3. Refer to Workshop Manual (GTR) section 413-01, *Instrument Cluster* (88.20.01), and remove the instrument cluster.
4. Remove the defrost vent / register blend door actuator (Figure 1):
  - Disconnect the electrical connector.
  - Remove the three retaining bolts.
  - Remove the actuator.
5. Disconnect the instrument panel blend door actuator remote linkage (Figure 2):
  - Disconnect the electrical connector.
  - Disconnect the instrument panel door actuator remote linkage.
6. Remove the instrument panel blend door actuator (Figure 3)
  - Remove the retaining bolts.
  - Remove the actuator.
7. To install new actuators, reverse steps 1 - 6.
