# TECHNICAL BULLETIN

## Poor Idle Quality – Normally Aspirated AJ16 Engine – Valve Timing Modification

12-57

MODEL 4.0L Normally Aspirated 1995 MY DATE 8/95

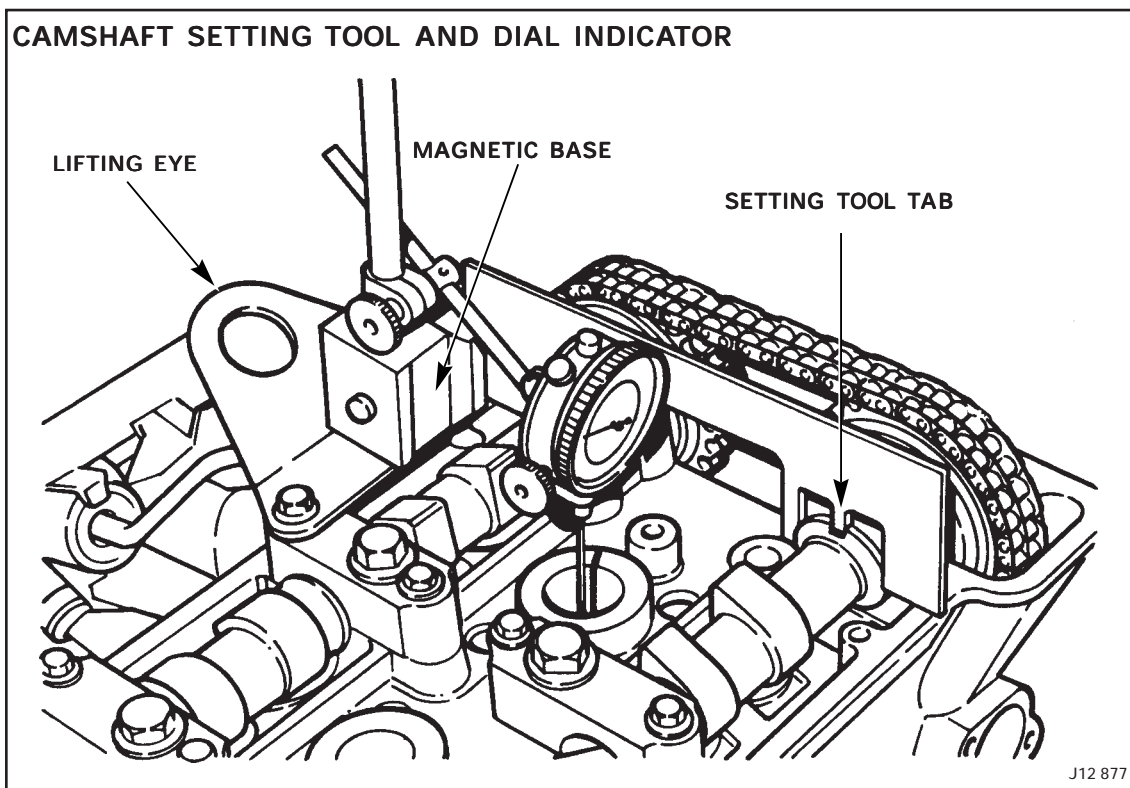
ILLUSTRATION 1

position. The valve timing overlap is reduced from 22 degrees on the 110 camshafts to 14 degrees on the 114 camshafts, Illustration 1.

5. Turn the crankshaft until the No. 1 cylinder is at Top Dead Center (TDC) on the compression stroke, i.e. with the cam lobes on the No. 1 cylinder pointing upwards as in Illustration 1. This position can be checked by temporarily inserting the camshaft setting tool 18G-1433/A into the slot on each camshaft.

7. On all engines, attach an engine lifting eye to the intake camshaft cap as shown in Illustration 1.
8. Position the magnetic base of a dial indicator gauge on the lifting eye.

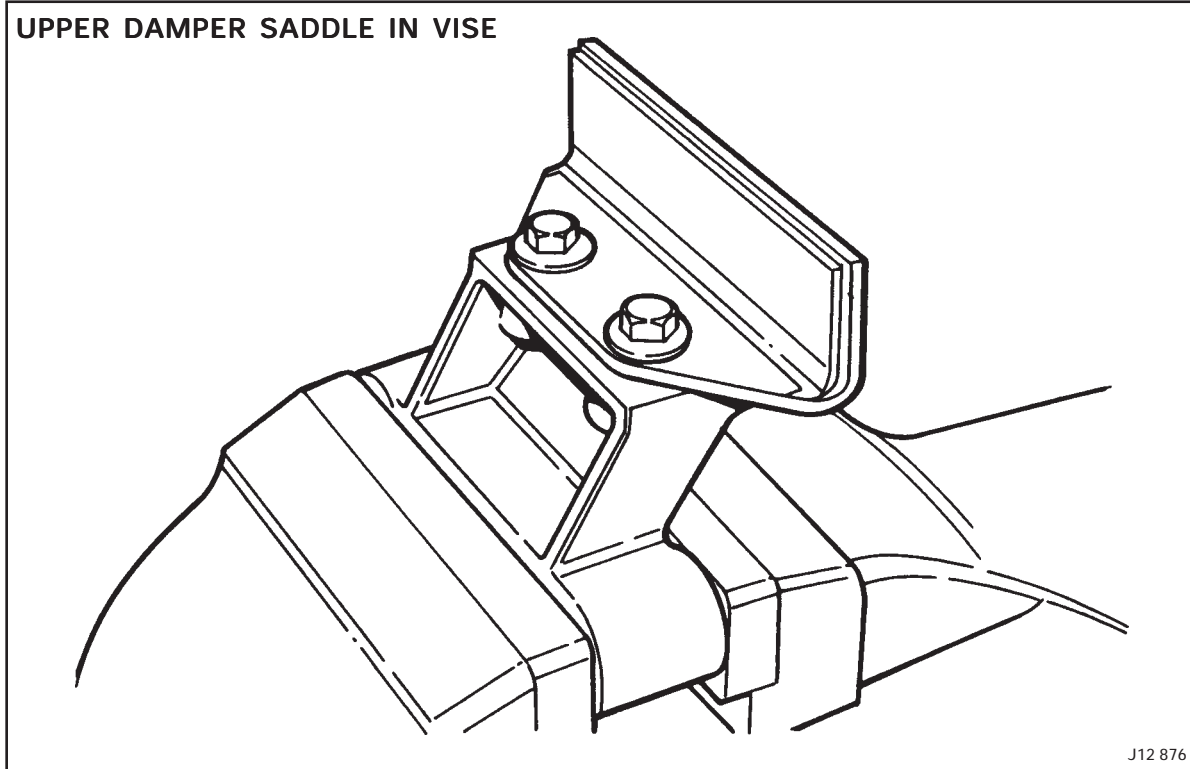
ILLUSTRATION 4

In addition, on engines with numbers below 9L103934 (XJS Range) or 9J103935 (Sedan Range), modify the bolts retaining the upper chain damper to the upper damper saddle as described at the appropriate point in the procedure.

28. Remove the setting tool, the dial indicator gauge, and the lifting eye. Torque camshaft bearing cap bolt to 12.5 - 16.9 lb ft (17 - 23 Nm).
29. On engines with numbers below 9L103934 (XJS Range) or 9J103935 (Sedan Range) only, remove the damper saddle retaining bolts, Illustration 4. Thoroughly degrease the bolts and the saddle. Apply Loctite 545, part number 54531 to the bolt threads and torque to 15.8 - 21 lb ft (21.5 - 28.5 Nm). Install the damper saddle using new cylinder head bolts and torque to 43.5 - 44.9 lb ft (59 - 61 Nm) plus 90 degrees as described in section 2.1 of the AJ16 Engine Service Manual.

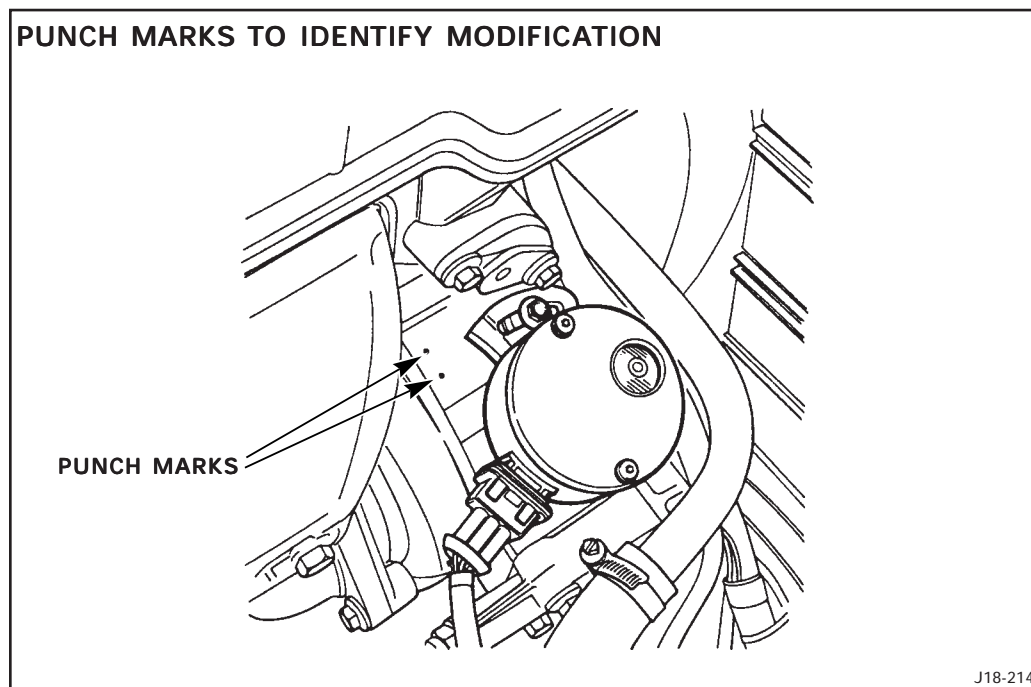
ILLUSTRATION 5

**NOTE:** Refer to Illustration 5, to identify engines with 110 camshafts that have already been modified.

33. Place two punch marks approximately 1/4 inch apart on the timing cover parallel to the lip, Illustration 5, to indicate that the modification was done.
34. Connect the battery negative cable and reset the clock.
