TECHNICAL BULLETIN

Camshaft Cover Oil Leaks – AJ16 Engine – Revised Bolt Torque Specification

12-60

MODEL 4.0L 1995-96 MY

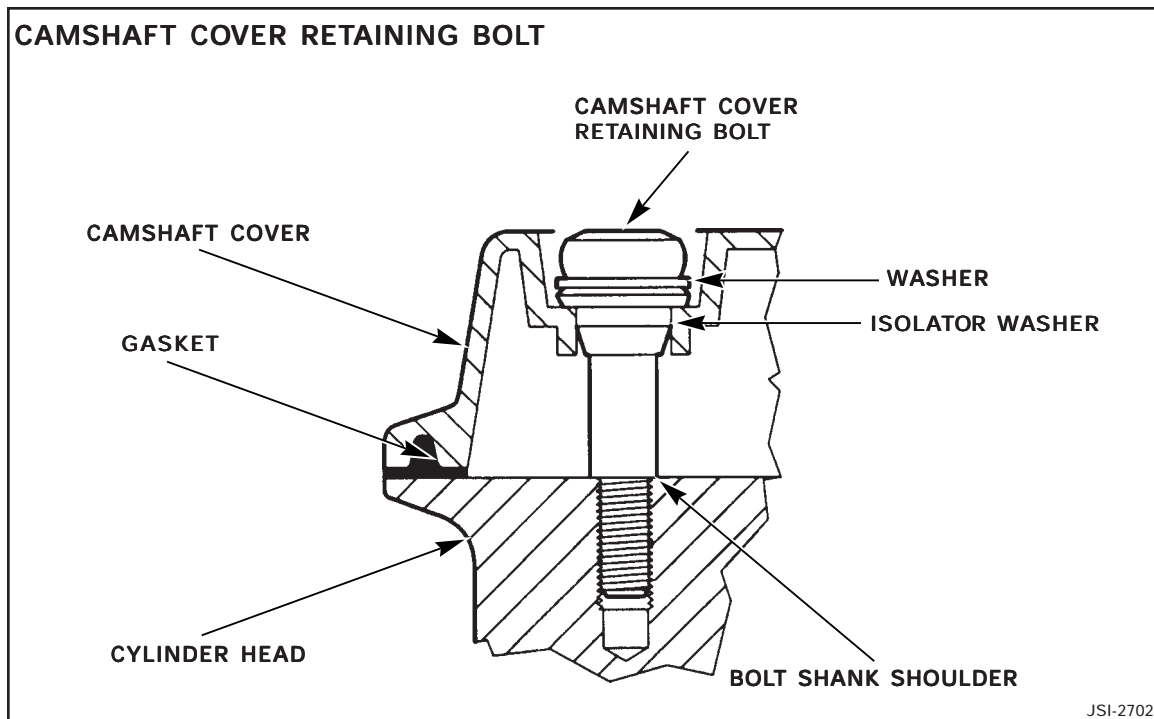
ILLUSTRATION 1

The torque specification for the camshaft cover retaining bolts has been revised beginning with VIN 767555 (Sedan Range) and VIN 225600 (XJS). The revised torque specification ensures that the shoulder on the shank of the bolt bottoms against the surface of the cylinder head (Illustration 1) to achieve even compression of the camshaft cover gasket and to reduce the incidence of oil leakage.
