MODEL  
XJ, S-TYPE,  
X-TYPE

NUMBER  
JTB00055

**TECHNICAL BULLETIN**

**Power Steering System Squeaking Noise Repair Procedure**

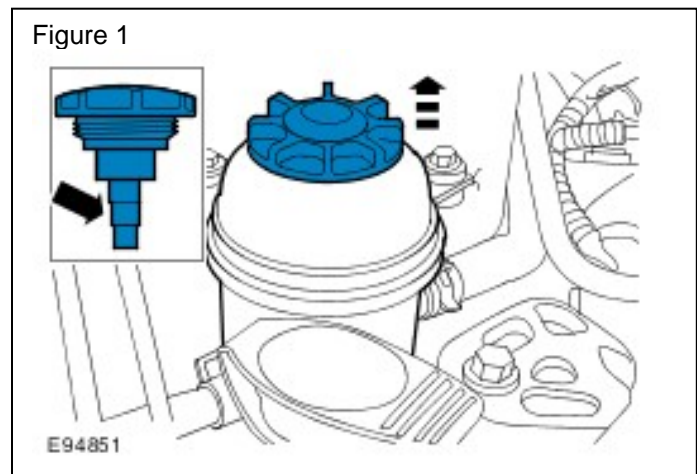
**Situation:** On some S-Type, X-Type and XJ Range vehicles within the VIN ranges above, a squeaking noise may be apparent from the power assisted steering system when the steering wheel is rotated in either direction. The noise is caused by a seal inside the steering rack. The noise can be transmitted through the steering column and steering wheel, making it difficult to diagnose. This bulletin does not address any other PAS noises, such as pump or drive belt related noises.

1. Open driver's door.
2. Ensure the gear lever is in either neutral or park, the parking brake is 'ON', and the ignition is 'OFF'.
3. Open hood and install fender protectors.
4. Remove the power steering fluid reservoir cap (and filter mesh on XJ and S-Type vehicles) and ensure the fluid level is correct. (Figure 1)
5. Using a suitable clean syringe, remove 50ml of steering fluid.

6. Replenish the power steering fluid reservoir with 50ml of the specified fluid additive (C2S 48887).
7. Affix the supplied label to the power steering fluid reservoir

8. Insert the temperature reading equipment probe into the power steering fluid reservoir (about halfway into the depth of the fluid).
