TECHNICAL BULLETIN

JAGUAR SERVICE	AIR Pump Clutch – Intermittent Operation – Service Action S458 MODEL 1993-94 MY 4.0L Sedan & XJS DATE 5/97	17-9 Amended 8/97
---	---	----------------------------------

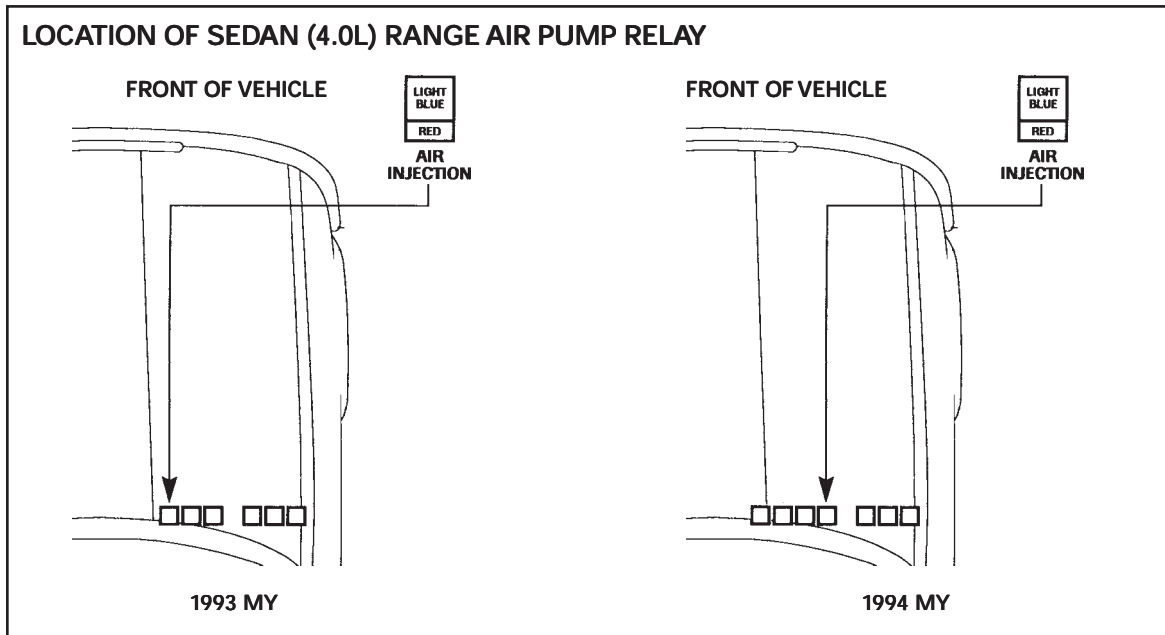
ILLUSTRATION 1

LOCATION OF XJS (4.0L) RANGE AIR PUMP RELAY

1. Open hood and replace the AIR pump relay (**red mounting base on Sedan; green mounting base on XJS**) with a sealed relay part no. LHF 6703AA.
2. Observe the AIR pump clutch while an assistant starts the engine. The clutch should engage as cranking begins. On a hot engine, the clutch should disengage after a few seconds. On a cold engine, more time will elapse until the clutch disengages at a coolant temperature of 34°C (95°F). Do not wait until the clutch disengages.
2. If proper operation is observed, no further action is required. Stop the engine and close the hood.
3. If the AIR pump clutch does not engage, follow normal diagnostic procedures (refer to AJ6 4.0L Engine Management System/OBD I Diagnostic Guide) and repair. Submit a claim under normal warranty procedures.
