TECHNICAL BULLETIN

Rough Idle/Engine Misfire – New Spark Plug Wires and Routing

18-43

MODEL XJS Range (V12) and XJ12 DATE 11/94

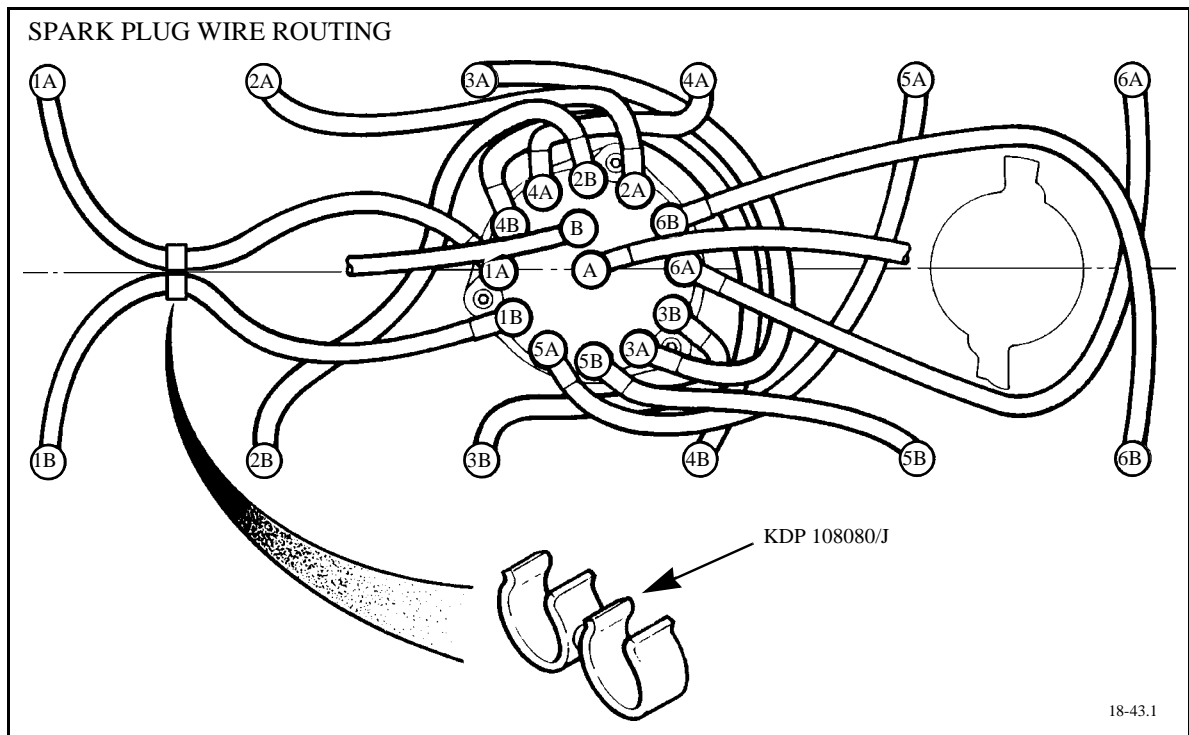
ILLUSTRATION 1

Rough idle and engine misfire conditions that develop after approximately 20,000 miles may be caused by high voltage leaks between the spark plug wires and cylinder head bolts.

If customers complain of engine misfire or rough idle after approximately 20,000 miles on V12 vehicles produced before the VIN numbers shown above, replace the spark plug wires with the latest version.

Route the new wires as shown in Illustration 1.

IMPORTANT: The clip (P/N KDP 108080/J) must be installed on the spark plug wires for cylinders 1A and 1 B as shown in the illustration.
