# TECHNICAL BULLETIN

## Hood Panel – Difficult To Latch – Revised Latch and Hood Release Lever Guard Introduced – Service Action S448

**76-96**

MODEL XJS Range 1994 - 1995 MY      DATE 11/94

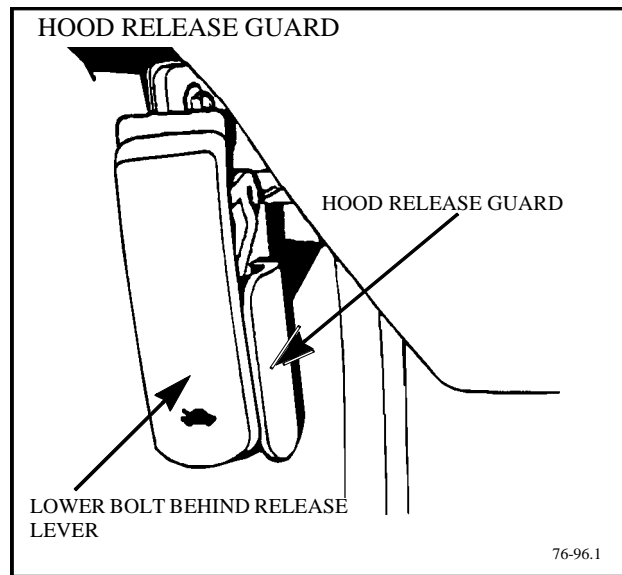
ILLUSTRATION 1

To prevent inadvertent operation of the hood release, a release lever guard was introduced in production at VIN 194776.

1. Remove the lower bolt of the hood release lever.
2. Align the guard as shown in Illustration 1 and replace the lower bolt.

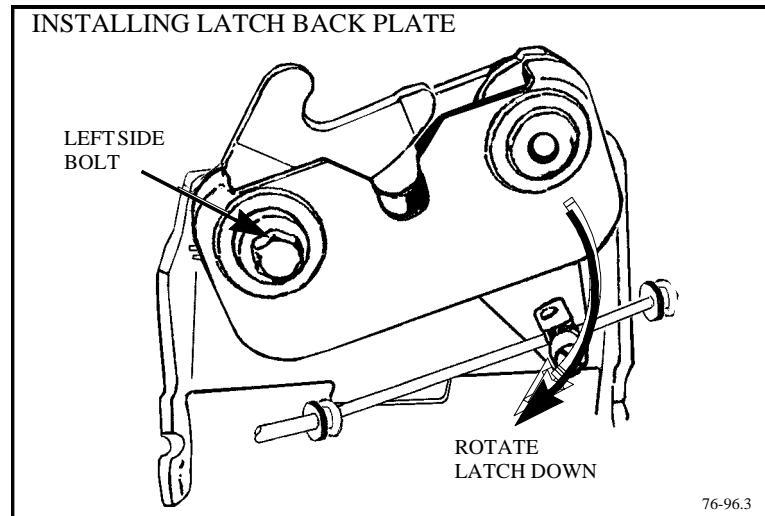
ILLUSTRATION 3

The revised latch back plate accomplishes the following:

- Prevents the latch pawl from going over center
- Increases the pawl return spring pressure to aid hood “pop-up” when the hood is released.

4. Place the new latch back plate behind the latch in the position shown in Illustration 3. Insert the left side bolt through the back plate to use as a pivot.
5. Rotate the right side of the latch down to “wind up” the latch spring and insert the right side bolt.
