**SRS Airbag MIL Illumination – DTC 32 –
Secure Connector**

MODEL 1995-96 MY
Sedan Range
VIN
720001-777462

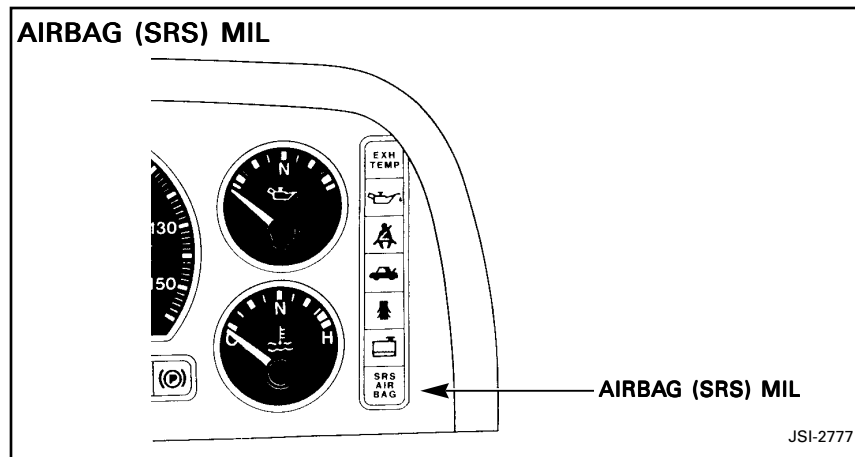
ILLUSTRATION 1

Some 1995-96 MY Sedan Range vehicles within the above VIN range may exhibit an Airbag fault where the Supplementary Restraint System (SRS) Airbag Malfunction Indicator Lamp (MIL) remains lit (Illustration 1) after the 6 second self-test function.

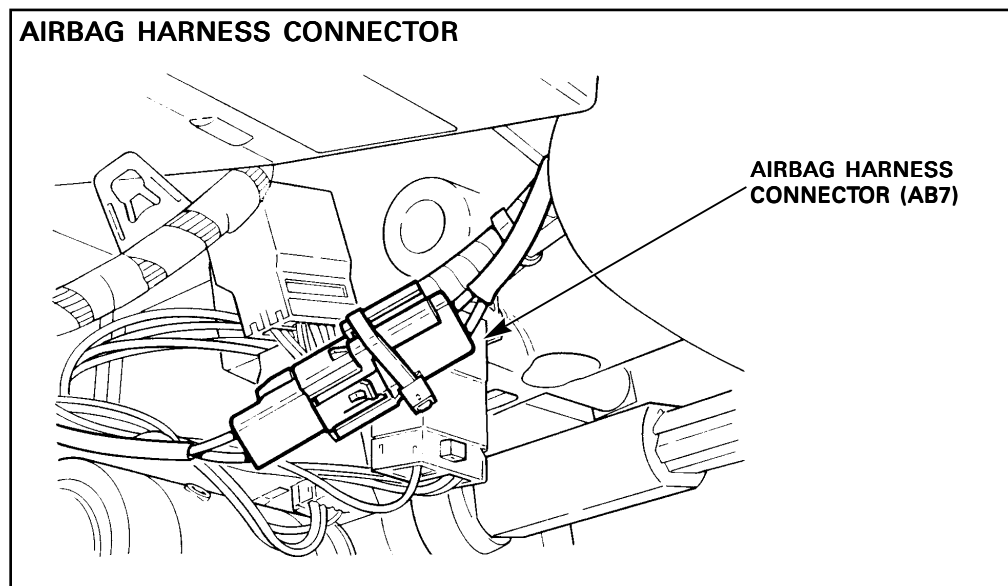
ILLUSTRATION 2

6. Remove the driver side dash liner and identify the harness connector for the driver's airbag (Illustration 2). The connector is black with a red/purple wire and a pink/brown wire, both covered by one yellow sleeve, between the airbag and the connector.
7. Disconnect the connector and inspect the terminals and the shorting bar.

10. Use the PDU to check that DTC 32 was not stored again. If not, proceed to step 11. If DTC 32 is still present, the connector is defective. Disconnect the battery negative cable and replace the cable reel cassette, refer to the XJ6-XJ12 Vehicle Service Manual, section 15.1.20, Cable Reel Cassette, Renew.
11. Position the connector against the adjacent harness (Illustration 2), and secure the connector to the harness using a tie strap to firmly hold the connector in position.
12. Reconnect the battery negative cable and wait 1 minute before proceeding to the next step.
13. Turn the ignition on and allow the Airbag/SRS to complete the self-test.
14. Use the PDU to verify that DTC 32 was not stored again.
15. Reset the clock.
