KIA MOTORS

NUMBER
044 [Revised]

TECHNICAL SERVICE BULLETIN

ECM UPGRADE WITH TP SENSOR REPLACEMENT – MIL ON WITH DTC P2135 / P0638

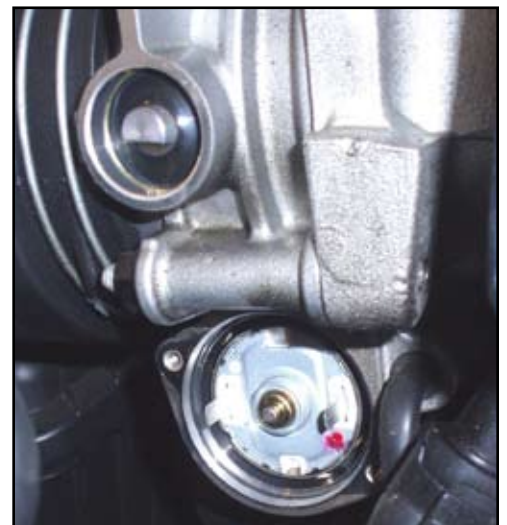
**The O-ring sometimes will stick to the housing during removal.
Be sure to remove if this occurs.**

4. Remove the TP sensor from the ETC actuator.

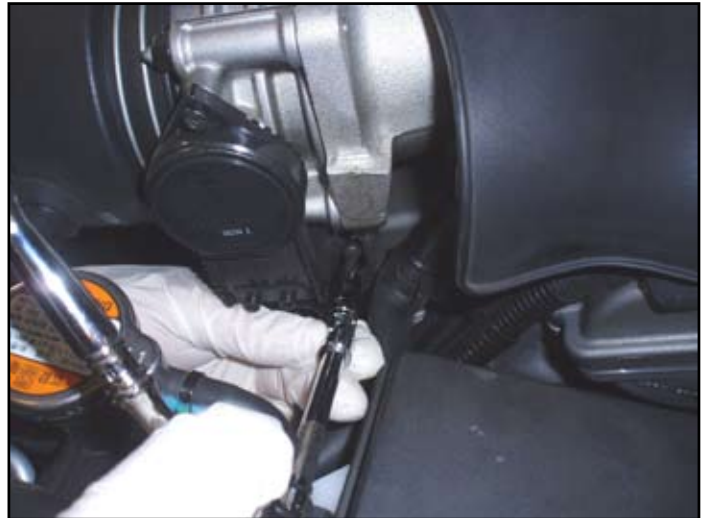
On p/n 35107 3C100FF For 35107 3E100FF, the 4th hole is not used.

2. Install the new TP sensor to the ETC actuator and tighten the Torx T-20 screws hand tight only. Use Loctite® Threadlocker Green 290 on screws during assembly.
