MODEL
Optima (MS)
Sportage (KM)

NUMBER
038

TECHNICAL SERVICE BULLETIN

2.5L/2.7L (DELTA) ENGINE HESITATION / MIL ILLUMINATION / P0123

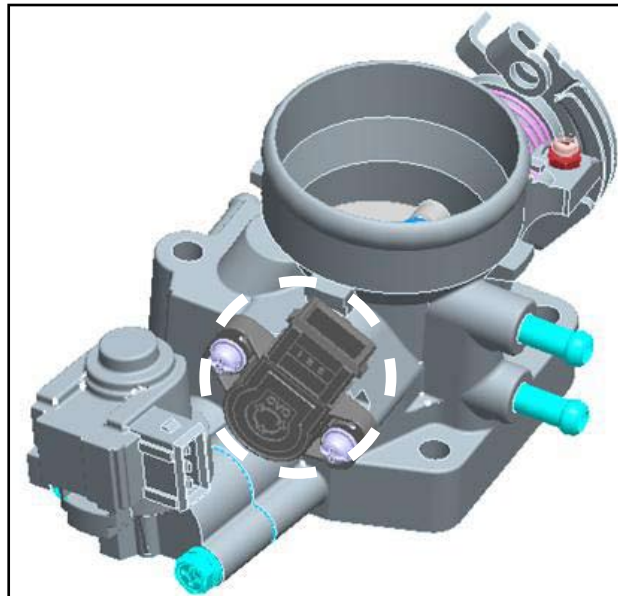
Some 2001-2006 Optima (MS) produced between 10-07-2000 ~ 08-31-2005, equipped with the 2.5L or 2.7L (V-6) Delta Engine and some Sportage (KM) models produced between 10-28-2004 ~ 05/18/2007 equipped with the 2.7L (V-6) Delta Engine are applicable for this bulletin. Improper throttle position sensor values may cause the engine to hesitate under loads or cause the illumination of the MIL. To correct for this condition, the throttle position sensor (TPS) has been improved.

Part Number	
Previous	New
35170 37100	35170-37100FFF
