<h1>TSB-Local</h1>	Model	Rio UB
		Group	Driveshaft and axle(31)
		TSB No.	KCE11-31-P040-UB;C21VA
Subject Drive Shaft Washer Replacement	Published	8/26/2011	
	TSB Type	Service Action	
	Area & Distributor	U.K (C21VA)

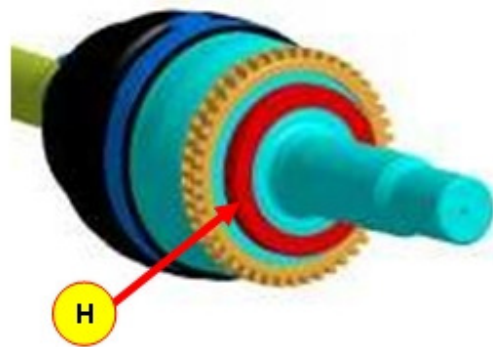
Some Rio MY12 (UB) vehicles may experience a 'creaking' noise emanating from between the drive shaft and front axle when turning.

It is possible that the drive shaft plastic washer was not installed during production. In these cases, clean the area thoroughly and fit the steel washer.

Replace both LH and RH drive shaft washers with a new one following the Service Procedure below.

7. Remove the drive shaft plastic washer (H), and replace with the new drive shaft steel washer supplied by Mobis.
