GROUP Body	MODEL 2012MY Rio (UB)
	NUMBER 086	DATE December 2011
TECHNICAL SERVICE BULLETIN		
SUBJECT: RIO (UB) INSTRUMENT PANEL PAD NOISE REPAIR

SUBJECT: RIO (UB) INSTRUMENT PANEL PAD NOISE REPAIR

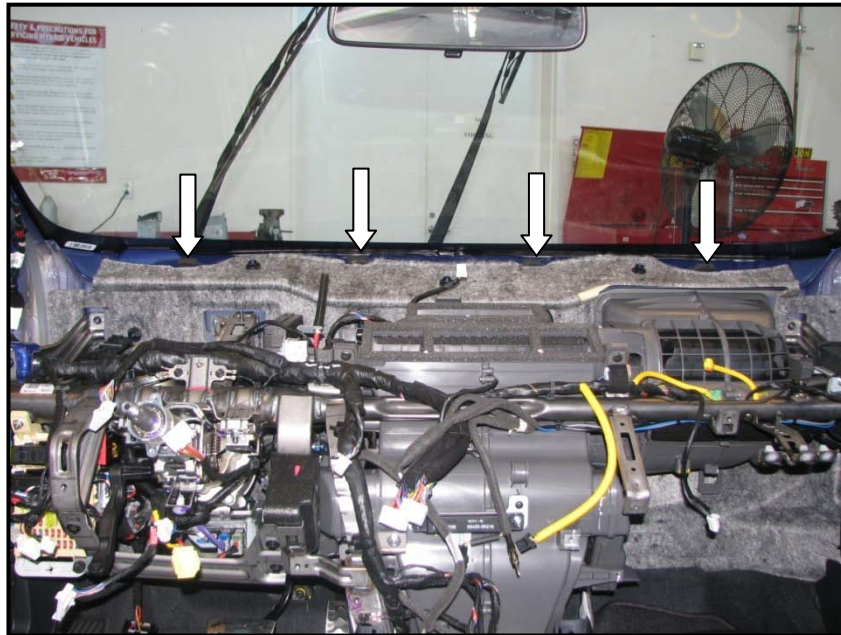
This bulletin provides information related to Rio (UB) vehicles produced from Start of production to November 11, 2011 that may experience a squeaking, rubbing or creaking noise emitting from the upper instrument panel pad area during normal driving conditions or while going over bumps or rough roads. These noises may be more prevalent during colder temperatures. To repair this condition, perform the following procedure outlined in this TSB.

Instrument panel pad contact tabs (arrows) will require a felt type insulation material applied to each of the four (4) tabs.

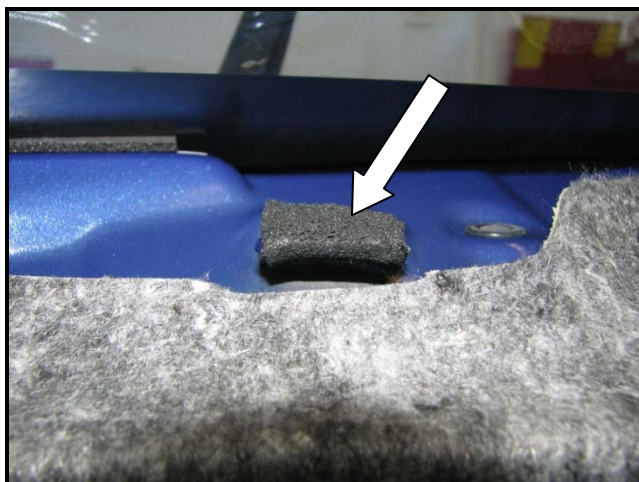
5. Close-up view of insulating material applied to instrument panel pad contact tab.
