GROUP Chassis	MODEL 2009MY Rondo (UN)
	NUMBER 021	DATE February 2010
<b>TECHNICAL SERVICE BULLETIN</b>		
<b>SUBJECT:</b> SERVICE ACTION: 2009MY RONDO (UN) FRONT STRUT UPPER NUT RETIGHTENING (SA028)

The issue number is **SA028**.

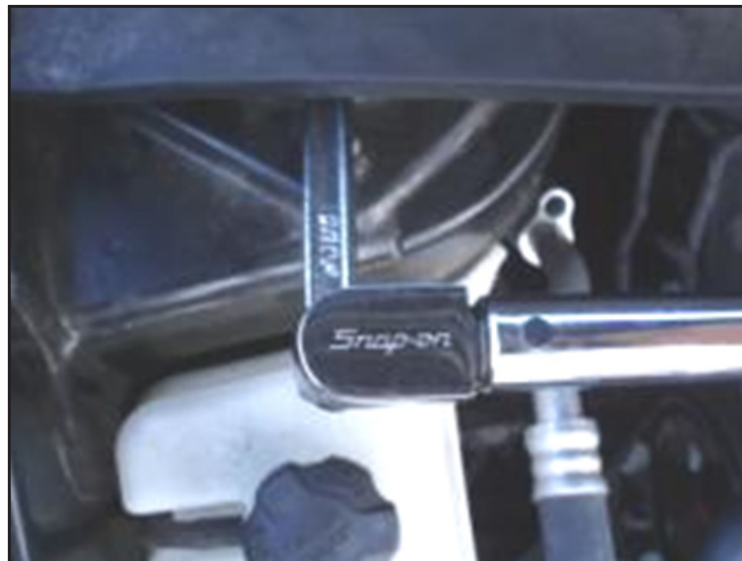
*Front strut upper nut tightening procedure*

This bulletin provides information relating to some 2009MY Rondo (UN) vehicles built between April 9, 2009 ~ July 16, 2009. While driving on an uneven road, some vehicles may experience abnormal noise originating from the upper area of the front strut. Use a torque wrench and the 6" torque adapter tool to retighten the front strut upper nuts (large, self-locking) on both sides to specified torque specification.

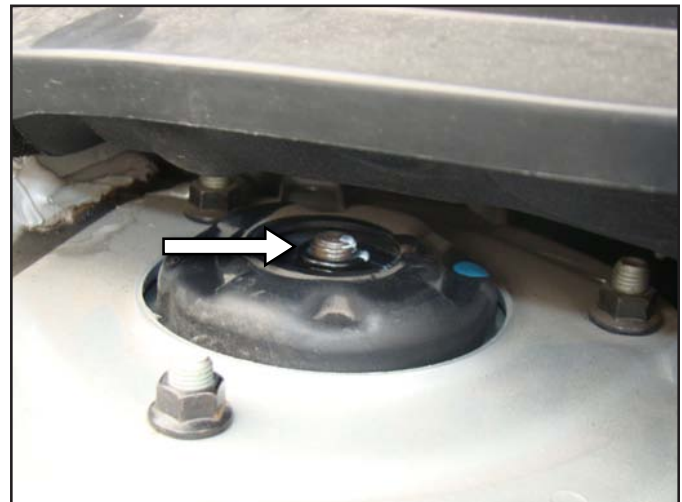
2. Photo shows upper strut cover removed and location of the front strut upper nut that will need to be tightened to the specified torque specification.
