MODEL
**2011-2013MY
Sorento (XM)**

TECHNICAL SERVICE BULLETIN

SUBJECT: FRONT STRUT BEARING REPLACEMENT

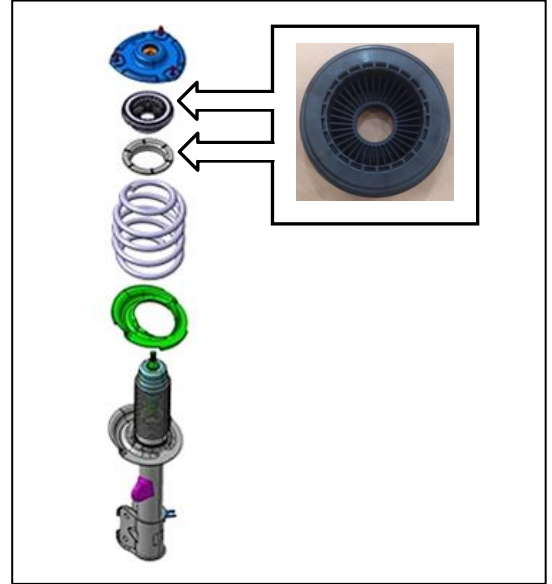
This bulletin provides the procedure for replacing the front strut bearings on some 2011-2013MY Sorento (XM) vehicles, produced from October 26, 2009 through January 21, 2013, which may exhibit a creaking noise emanating from the front of the vehicle when turning the wheel, quickly, at slow speeds. This concern may be caused by corrosion of the front strut bearing due to water or debris entry and is more commonly found in regions where heavy amounts of road salt are used for de-icing in the winter months. Follow the procedure outlined in this bulletin to replace both front strut bearings to resolve the concern.

1. Remove and disassemble the front strut assemblies by referring to the service procedures in the applicable Workshop Manual on KGIS.
2. Replace the original front strut bearing and the upper spring pad with the new one-piece part.

3. Reinstall all removed components by reversing the order of removal.
