| | GROUP Service Campaign | MODEL 2011MY Sportage (SL) |
| | NUMBER SC086 | DATE November 2010 |
| SUBJECT: 2011MY SPORTAGE LX DRIVER'S SIDE POWER WINDOW SWITCH ASSEMBLY VOLUNTARY SERVICE CAMPAIGN | | |

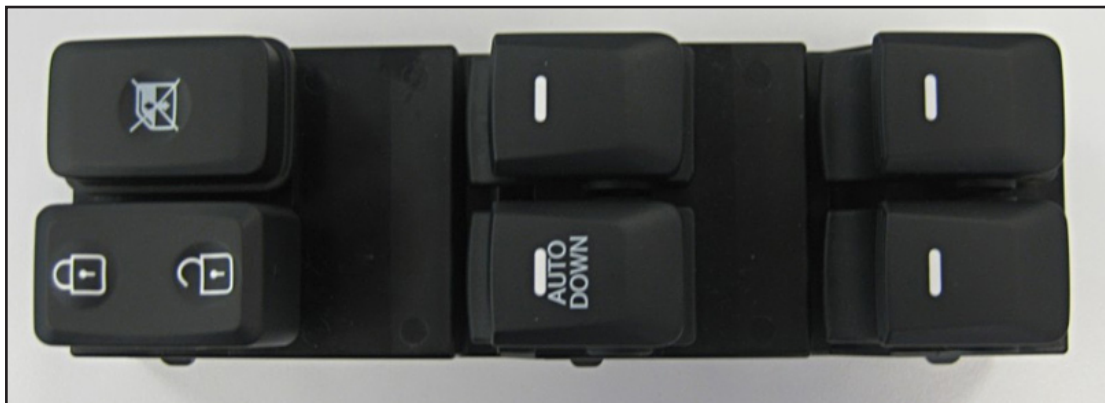
Power Window Switch Module Assembly

This bulletin provides information relating to some LX Sportage vehicles equipped with "Auto Down" function and produced from the start of production through October 27, 2010. In affected vehicles, the window may not raise or lower even though the power window switch is actuated. To correct this condition and improve customer satisfaction Kia is launching this Service Campaign and replacing the power window switch module assembly on all affected 2011 Sportage vehicles that fall within the vehicle production range. Kia is requesting the completion of this Service Campaign on all affected 2011MY Sportage vehicles in dealer stock prior to retail sales.
